Service Bulletin

Bulletin No.: PI0914C

Subject: MyLink Radio – Software Enhancement Update to Add BringGo and TuneIn Radio Applications and Siri Eyes Free – U.S. and Canada Only

Models: 2013 Chevrolet Sonic Built Prior to February 8, 2013
2013 Chevrolet Spark Built Prior to February 18, 2013
2013 Chevrolet Trax Built Prior to March 11, 2013
Equipped with Uplevel Radio (RPO UF7)

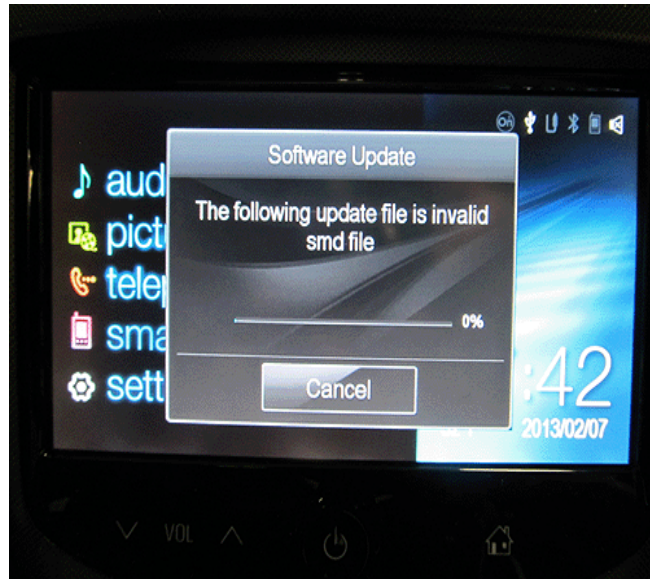
3286662

8. If you see the message as shown above “The following update file is Invalid SMD file,” continue to the next step. Otherwise, skip to Step 14.
