Service Bulletin

Bulletin No.: PI0914D

Subject: Software Enhancement Update – MyLink Radio to Add Siri Eyes-Free, BringGo Navigation and TuneIn Global Internet Radio Applications (U.S. and Canada Only)

Models: 2013 Chevrolet Sonic Built Prior to February 8, 2013
2013 Chevrolet Spark Built Prior to February 18, 2013
2013 Chevrolet Trax Built Prior to March 11, 2013
Equipped with Uplevel Radio (RPO UF7)

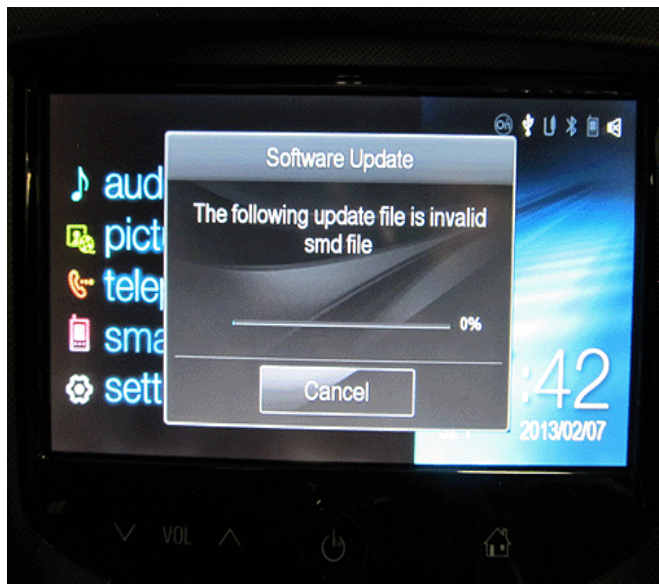
3286662

8. If you see the message as shown above “The following update file is Invalid SMD file,” continue to the next step. Otherwise, skip to Step 14.
