# Service Bulletin

Bulletin No.: PI0916B

**Subject:** Floor/Carpet Wet at Front Passenger Side Under Dash, or at Any Front/Rear Footwell Area

**Models:** 2011-2013 Chevrolet Caprice PPV

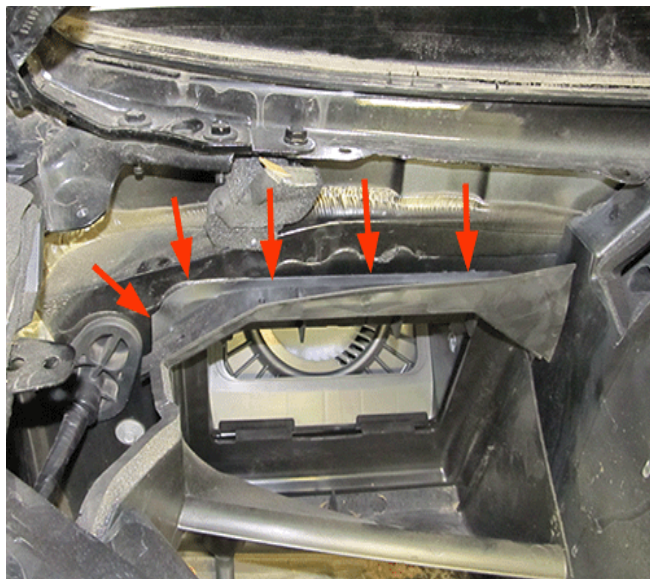
3291073

- Water intrusion in the seam (1) between the HVAC case and the cowl.

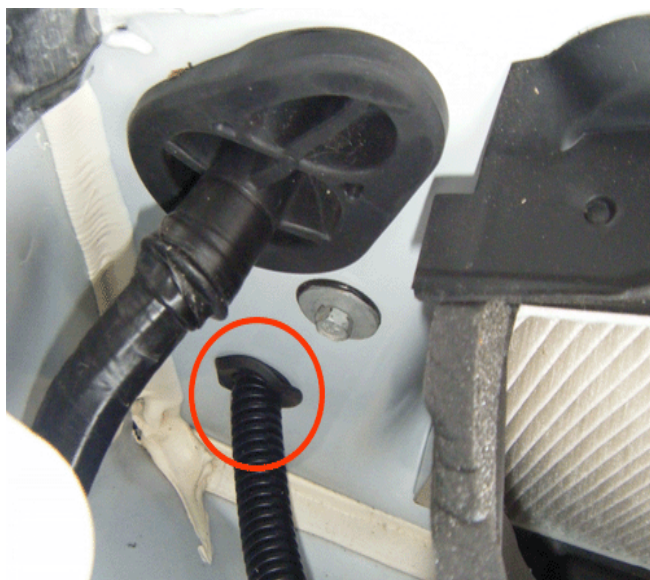
3291074

- For some police equipped vehicles, water may run on the wire harness exiting the HVAC case, then follow along the conduit into a grommet/hole (shown circled in the graphic above) in the cowl, and finally run into the vehicle interior.

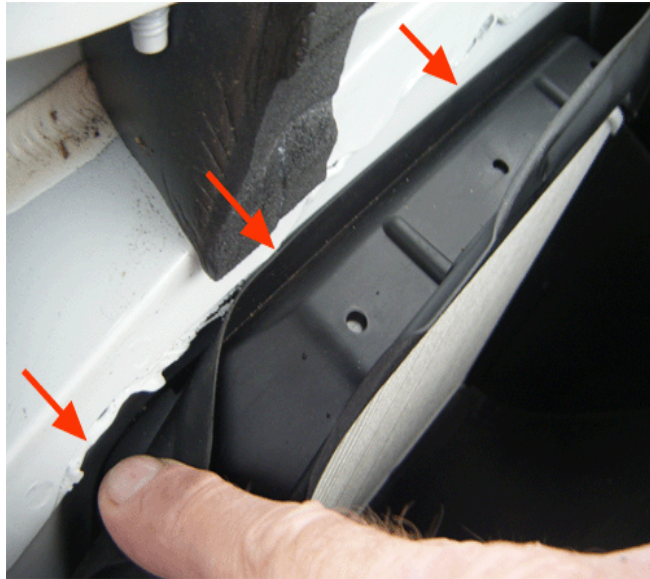
3291076

2. Inspect the seam at the top of the HVAC case, where the case sits against the cowl. The seam is commonly not sealed in this area and water coming off the windshield may find a path behind the case and leak into several places in the interior under the dash.

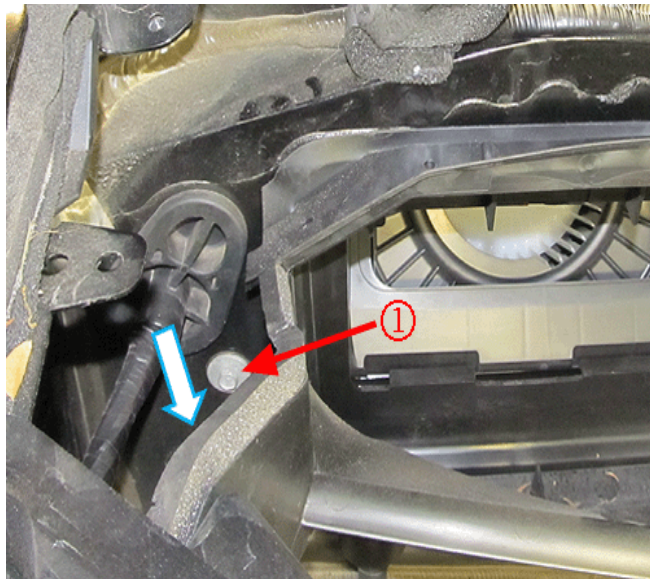
3291078

4. Inspect the cowl area outside the HVAC case for the possible existence of a wiring harness associated with certain police equipped vehicles. If equipped, the grommet/hole location for the harness will be just below the bolt (1) shown in the graphic above.

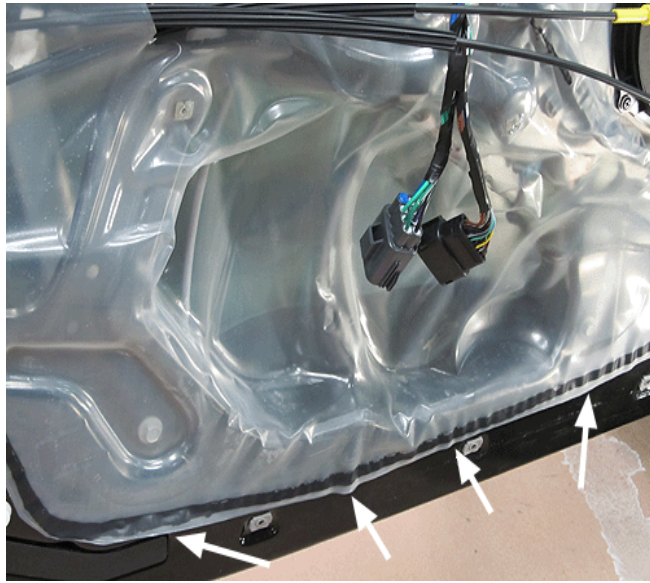
3392287

The cause of this condition may be that water, normally being channeled through a side door, may bypass an improperly sealed water deflector and create a leak path into the vehicle. Because of the increased mirror/window switch wiring harness content, this condition most commonly occurs at the driver door, but may occur at any front or rear side door.

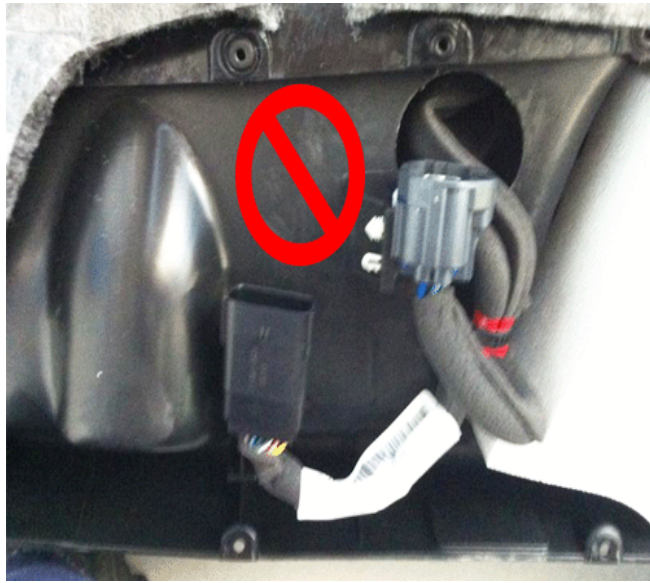
**Important:** The correct harness routing is shown in the first graphic above. An example of an incorrect routing is shown in the second graphic.

- 8.1. Ensure the harnesses are routed as shown in the first graphic above. It may be necessary to unclip the grey connector and reroute the one harness underneath the other to achieve this.

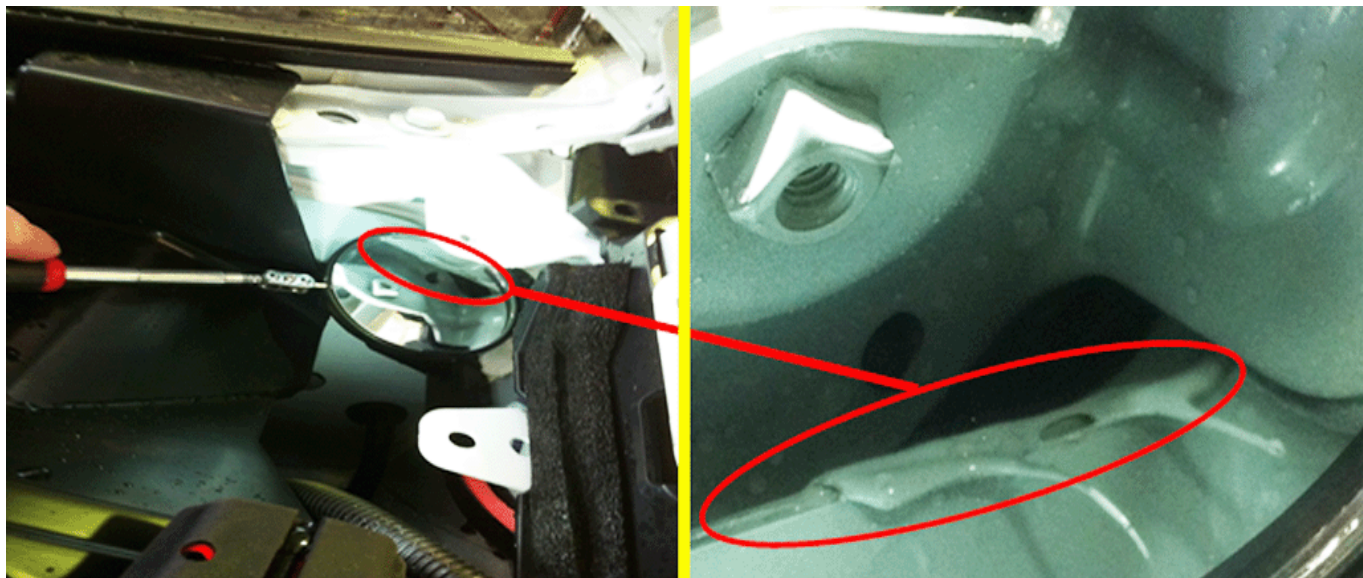
3655071

- 4.1. Use an inspection mirror to view a section of the seam underneath the cowl brace.
- 4.2. Apply water from a hose directly at the seam.
- 4.3. If leaking, water droplets will be seen dripping down the A-pillar. It may take at least three minutes for the water droplets to show.
