Service Bulletin

Bulletin No.: PI0918

Subject: Information on Avoiding Boot/Washer Damage During Front Lower Control Arm/Ball Joint Service

Models: 2014 Chevrolet Impala
Condition/Concern

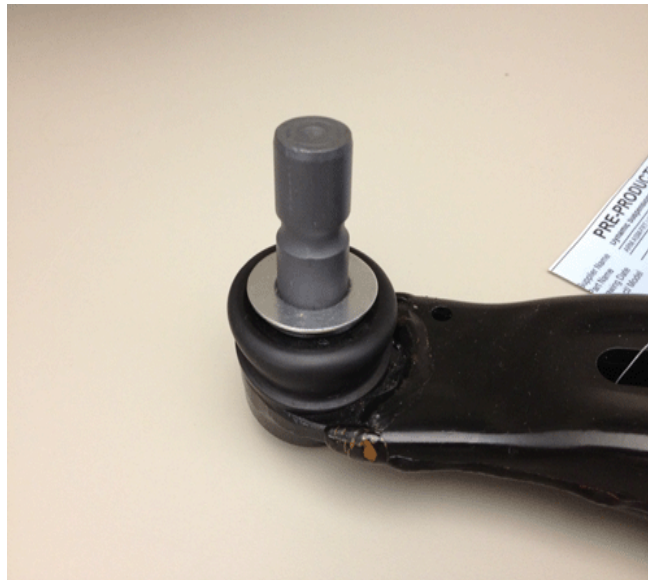
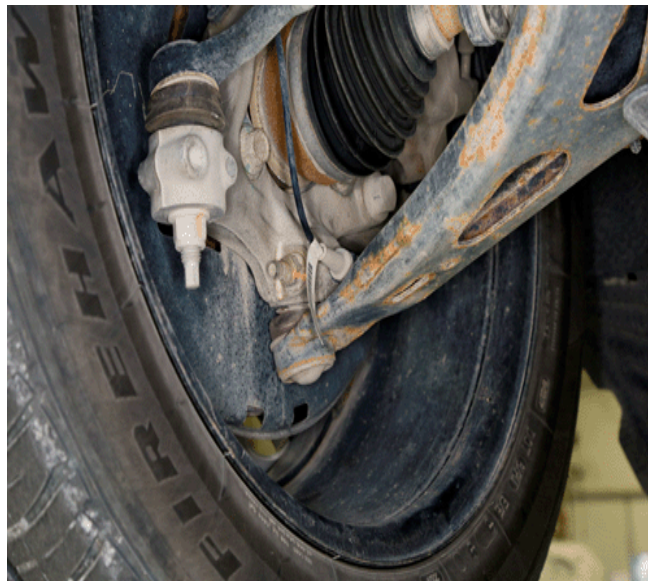
These vehicles utilize a new style boot on the front lower control arm ball joint as shown in the images above. This boot has an integrated metal washer that helps seal the boot against the steering knuckle. This steel washer and boot can be damaged during service if it is used as a pry point to separate the control arm from the steering knuckle. If damaged, the complete control arm requires replacement. This boot and washer are integral to the control arm and are not serviced or available separately.

Do not pry on the boot or washer when separating the lower control arm from the steering knuckle. Per the service procedure, pry open the pinch joint to assist in separation. If necessary, use the steel body of the control arm as a surface to pry against to aid in separation.
