## Service Bulletin

# PRELIMINARY INFORMATION

Subject: Malfunction Indicator Lamp (MIL) On, DTCs P059F and P069E Set

#### Models: 2013 Chevrolet Malibu Equipped with Front Lower Grille Shutters (RPO VRI) and Built Prior to the VIN Breakpoints in the Table Below

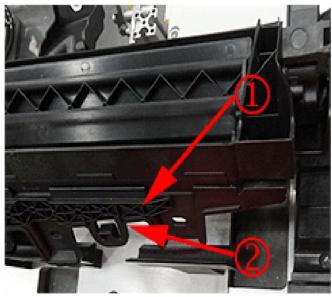
2906217

- 1. Inspect for debris blocking the movement of the shutter louvers.
- 2. Inspect for any signs of impact.
- 3. Remove the front bumper fascia. Refer to the Front Bumper Fascia Replacement procedure in SI.

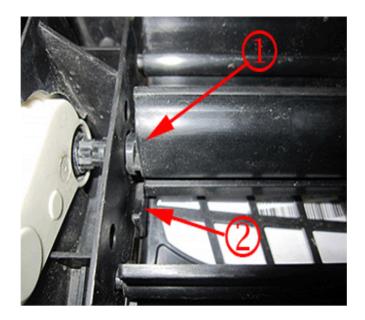
2906215

4. Inspect for proper installation of the shutter assembly. Make sure the clips (1) are fully engaged and aligned between the bracket (2) and the shutter assembly.

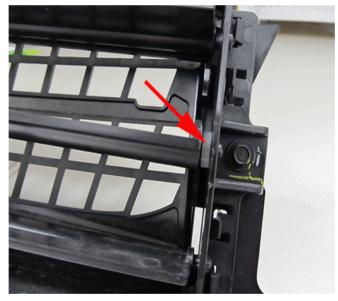
2906401

The MIL may illuminate if shutter movement is obstructed or if the drive louver (louver connected to actuator) has over-rotated past its stop.

5. Inspect the drive louver (louver connected to actuator) (1) to determine if it has rotated past its stop (2). If the louver is shoved all the way to the passenger side of the shutter frame, the louver may bypass the stop. This will cause the drive louver to over-rotate and set the DTC. If the drive louver has over-rotated past its stop, install a washer (obtained from WPC) between the drive louver and the shutter frame using the steps below.

- 5.1. Remove the drive louver from the pivot hole on the shutter frame. Gently grasp or pry to release.
- 5.2. Install the washer on the louver pivot pin.
- 5.3. Reinstall the drive louver into the pivot hole on the shutter frame.
- 6. Install the front bumper fascia. Refer to the Front Bumper Fascia Replacement procedure in SI.
