Service Bulletin

Bulletin No.: PI0929

Date: March, 2013

Subject: MyLink Radio – XM Inoperable, Service Camera Message On, No Bluetooth Function – GMNA Only

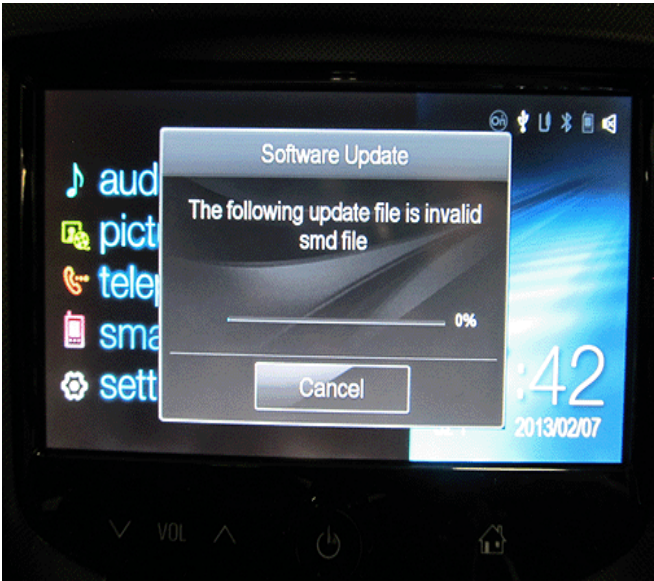
3286662

8. If you see the message as shown above “The following update file is Invalid SMD file,” continue to the next step. Otherwise, skip to Step 14.
