Service Bulletin

Bulletin No.: PI0931

Subject: Service Engine Soon (SES) Light On with DTCs P0171, P1101, and/or P0101 Set

Models: 2013 Buick Verano
Equipped with 2.0L Engine (RPO LHU)

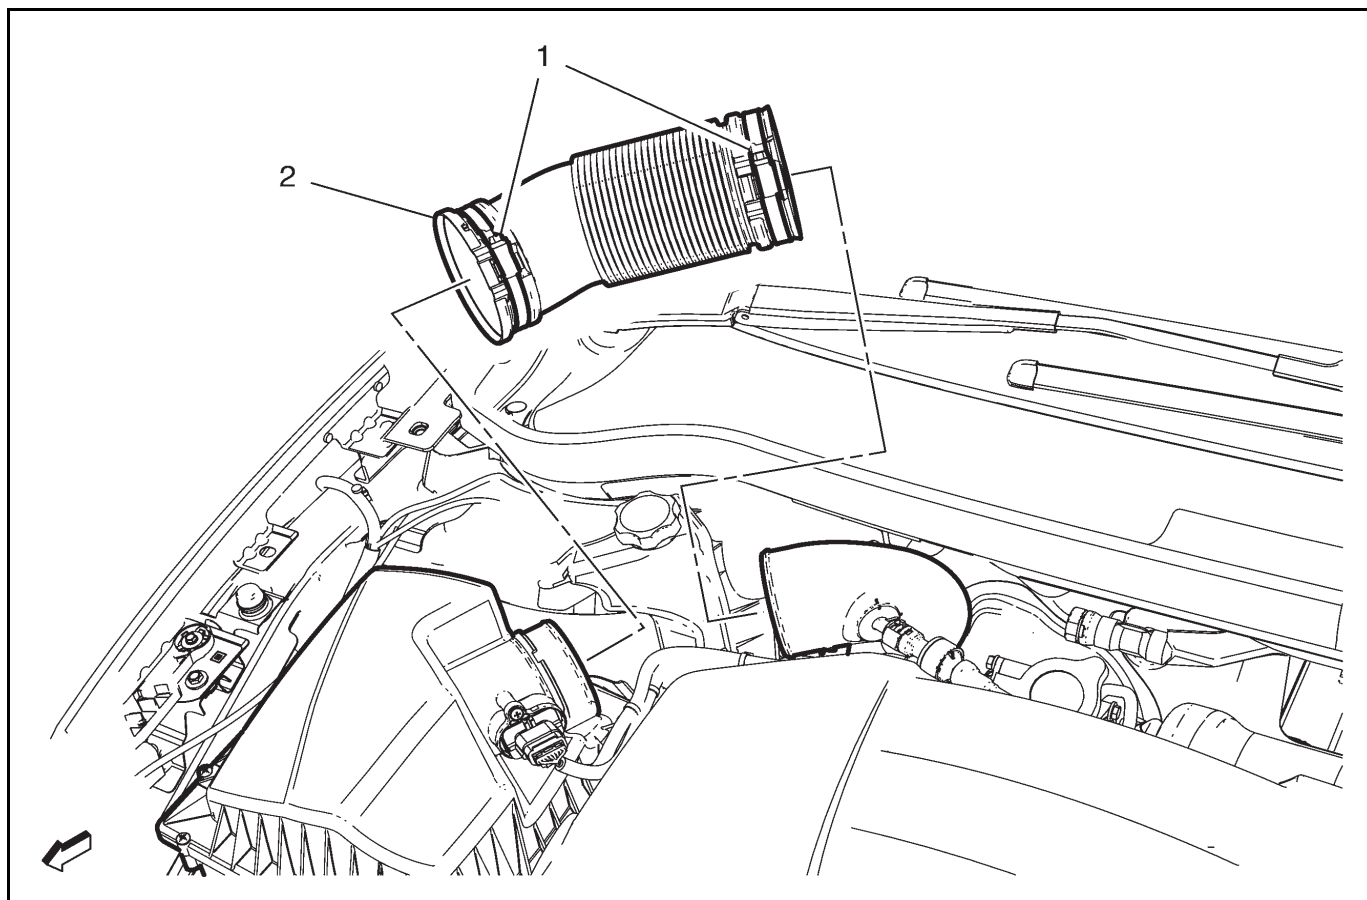
2699465

Some customers may comment that the service engine soon (SES) light is on. Upon further inspection, the technician may find P0171, P1101 and/or P0101 stored in history.

This condition may be caused by loose clamps on the air cleaner duct (1) as shown in the illustration above.

Inspect both clamps on the air cleaner outlet duct to ensure that the clamps are secured tightly.
