Service Bulletin

Bulletin No.: PI0936

Subject: Charge Port Door Will Not Open in Cold Weather

Models: 2013 Chevrolet Volt
With Part Built Between May Through August 2012

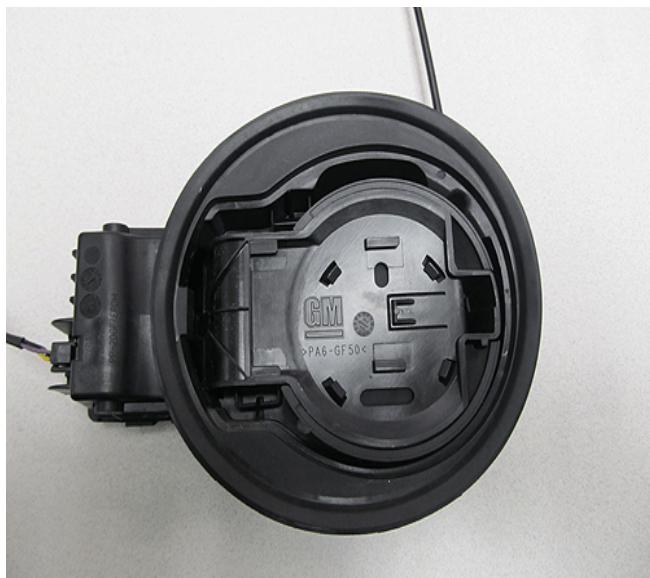
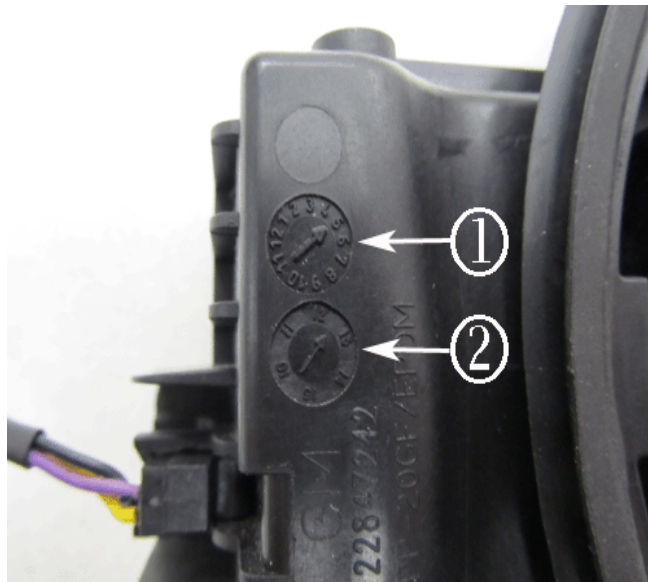
3336511

The hinge pin for the charge port door may have been misaligned when assembled. The charge port assembly has a time stamp located on the hinge. DO NOT use any part with a time stamp built between May through August 2012.

To verify the charge port assembly time stamp, remove the charge port housing – Refer to the pictures below (Showing a build date of May (1) 2012 (2)).

If the charge port door is built within the dates listed above, replace the charger port housing. Refer to Charge Port Housing Replacement in SI.

Note: It is critical that the receptacle is aligned and properly fastened to the charge port door assembly. If not, the door could stick to the misaligned receptacle.
