Bulletin No.: PI0937

# Service Bulletin

**Subject:** Service Engine Soon (SES) Light On with DTC P0137 Set

**Models:** 2013 Buick Verano  
Equipped with 2.4L Engine (RPO LEA)

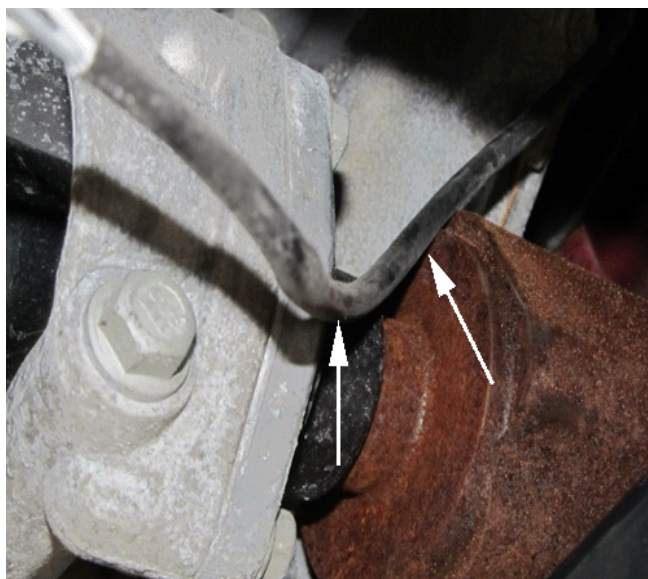
3329640

This condition may be caused by the heated oxygen sensor coming in contact with the axle shaft on the passenger side.
