# Service Bulletin

Bulletin No.: PI0947

**Subject:** Left Rear Side Door Molding Loose at Front Edge, Contacting Rear Edge of Left Front Door or Door Side Molding

**Models:** 2012 Chevrolet Traverse LTZ  
2012 GMC Acadia Denali

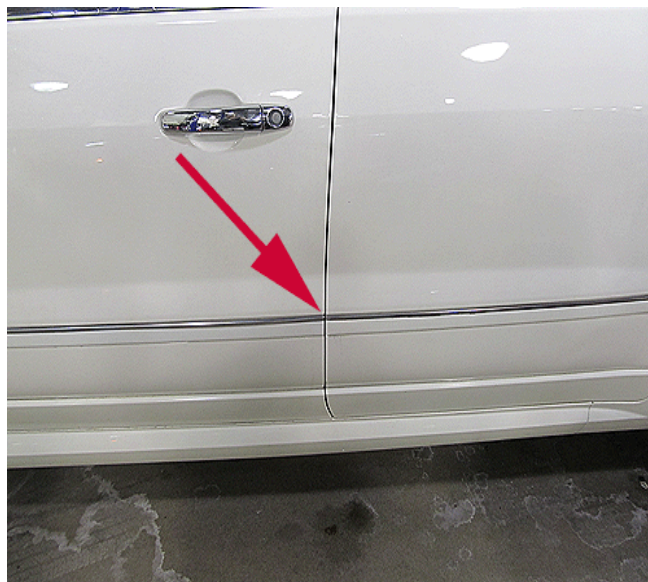
3267766

Some customers may comment that the left rear side door molding comes in contact with the left front door rear edge or left front door side molding. This contact condition may cause the rear side door molding to buckle or come loose from the door outer panel.

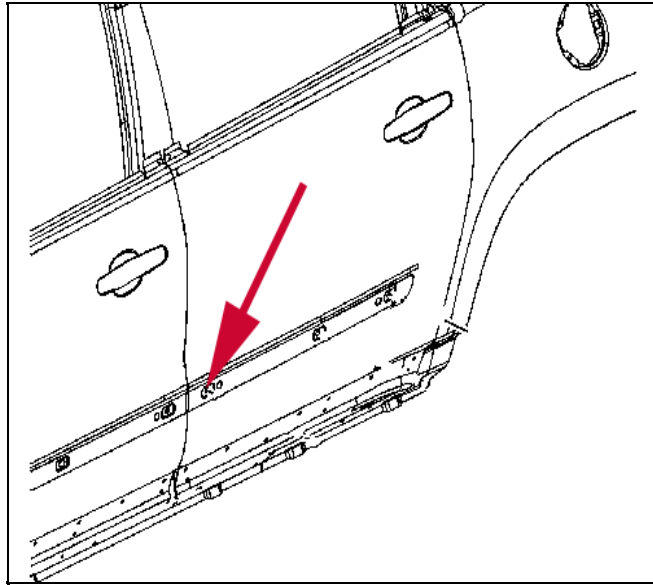
3267769

This condition may be caused by the forward locator hole in the door sheet metal being located too far forward on the outer door panel, allowing possible contact between moldings.
