Service Bulletin

Bulletin No.: PI0955

Subject: Sloshing or Clunking Noise From Rear Compartment When Turning, During Lane Changes, Harsh Braking or Traveling Over Bumps in Road

Models: 2014 Chevrolet Cruze
Equipped With 4 Cylinder Diesel Engine RPO LUZ

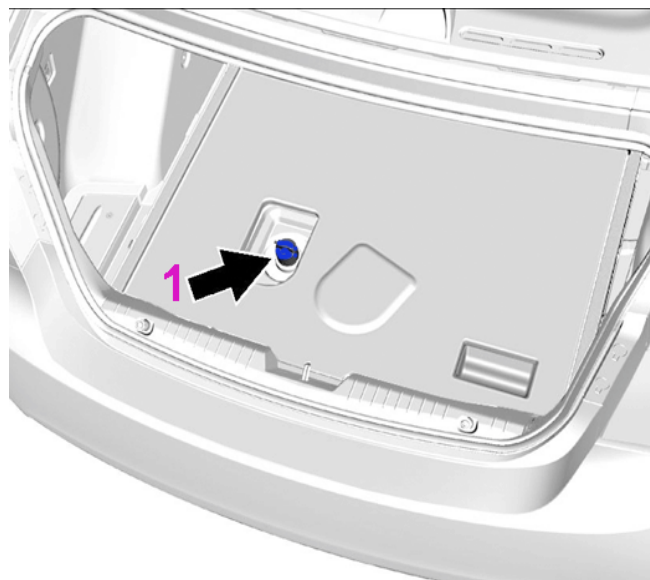
This condition may be caused by the diesel exhaust fluid (DEF) also known as emission reduction fluid sloshing around in the DEF tank, which is located under the load floor carpet in the trunk. This noise may become more noticeable as the level of the DEF fluid in the tank decreases.

To fill the DEF tank, raise the load floor carpet in the trunk and remove the blue filler cap (1) on the tank. Add DEF as needed. Do not overfill the tank.
