# Service Bulletin

### Subject: SERVICE HIGH VOLTAGE CHARGING SYSTEM Message Displayed on Driver Information Center (DIC), Hybrid/EV Charging System Disabled, DTCs Set

### Models: 2013 Chevrolet Volt Vehicles Built Prior to February 5, 2013

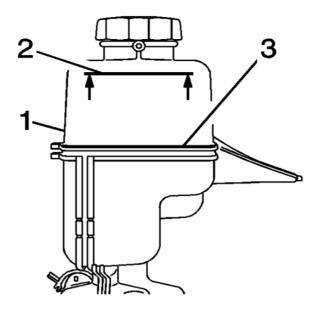
3347990

# *Notice:* When checking and adjusting the high-voltage (HV) battery surge tank (1) coolant level, disregard the factory level indicator markings (2). The proper coolant level is at or just above the top of the seam (3).

- 0.5. Visually inspect the coolant level in the high-voltage battery surge tank (1) and verify that the level is at or just above the seam (3).
  - ⇒ If the HV battery surge tank (1) coolant level is not at or just above the seam (3), Go to: Hybrid Cooling System Loss of Coolant (Battery) in SI.

- $\Rightarrow$  If the HV battery surge tank (1) coolant level is **at** or **just above** the seam (3), Go to Step 6.
- 0.6.Remove the front compartment front sight shield. Refer to Front Compartment Front Sight Shield Replacement in SI.
