Service Bulletin

Bulletin No.: PI0961A

Subject: SERVICE HIGH VOLTAGE CHARGING SYSTEM Message Displayed on Driver Information Center (DIC), Hybrid/EV Charging System Disabled, DTCs Set

Models: 2011-2014 Chevrolet Volt

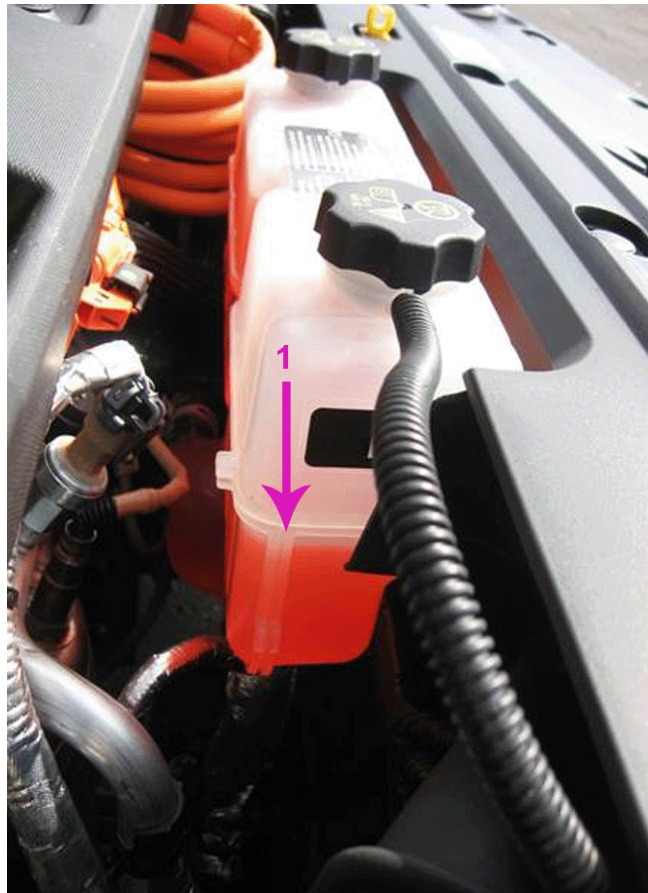
3651144

0.5.Visually inspect the coolant level in the HV battery surge tank and verify that the coolant level is **at or near** the seam (1) of the surge tank.

⇒ If the HV battery surge tank coolant level is **not at or near** the seam (1) of the surge tank, Go to the section titled: **Pressure Test Procedure** in this Diagnostic.

- 0.13. Upon completion of the Hybrid/EV battery pack coolant pump bleed procedure, **adjust** the surge tank coolant level to a position just above the seam (1), by performing this procedure, — Drive Motor Battery Cooling System Draining and Filling — Removing Excess Coolant From System in SI.
