Service Bulletin

Bulletin No.: PI0961B

Subject: SERVICE HIGH VOLTAGE CHARGING SYSTEM Message Displayed on Driver Information Center (DIC), Hybrid/EV Charging System Disabled, DTCs Set, Revised HV Battery Surge Tank Coolant Fill Level

Models: 2011-2014 Chevrolet Volt

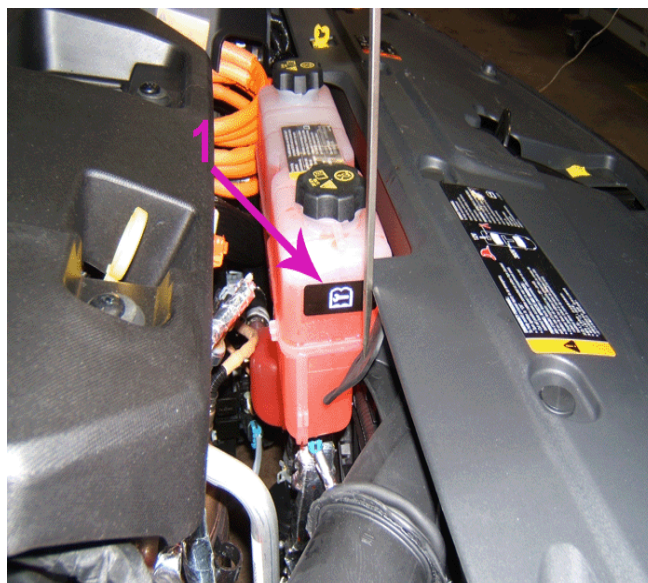
3672187

0.5. Visually inspect the coolant level in the HV battery surge tank and verify that the coolant level is **at the top of the label (1)** on the side of the surge tank.

⇒ If the HV battery surge tank coolant level is **not at the top of the label (1)** on the side of the surge tank, Go to the section titled: **Pressure Test Procedure** in this Diagnostic.

⇒ If the HV battery surge tank coolant level is **at the top of the label (1)** on the side of the surge tank, Go to Step 6.

- 0.13. Upon completion of the Hybrid/EV battery pack coolant pump bleed procedure, **adjust** the surge tank coolant level to the **top of the label (1)**, by performing this procedure, — Drive Motor Battery Cooling System Draining and Filling — Removing Excess Coolant From System in SI.
