# Service Bulletin

Bulletin No.: PI0962

**Subject:** Radio Resets, Navigation Inoperative, Map Not Displayed, DVD Will Not Play or Resume, Bluetooth<sup>®</sup> Inoperable, Radio Lockup, Voice Recognition Cuts Off, USB Source not Returning to Last Song, OnStar<sup>®</sup> Default Volume Low

**Models:** 2013 Buick Enclave  
2013 Chevrolet Traverse  
2013 GMC Acadia  
Equipped with Radio RPOs UHU, UG4, UGU, UGY, UGX

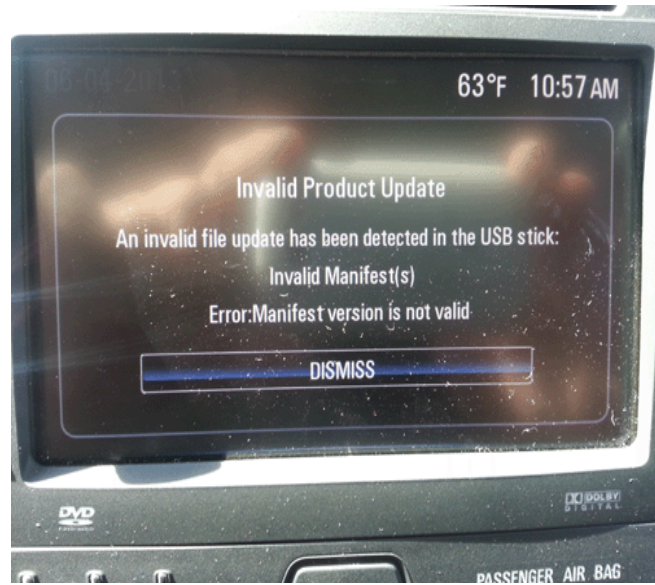
3462549

**Note:** If the following screen above is shown on the screen, the radio already has the latest calibration installed and no further action is required.
