Service Bulletin

Bulletin No.: PI0962A

Subject: Radio Resets, Navigation Inoperative, Map Not Displayed, DVD Will Not Play or Resume, Bluetooth® Inoperable, Radio Lockup, Voice Recognition Cuts Off, USB Source not Returning to Last Song, OnStar® Default Volume Low

Models: 2013 Buick Enclave
2013 Chevrolet Traverse
2013 GMC Acadia
Equipped with Radio RPOs UHU, UG4, UGU, UGY, UGX

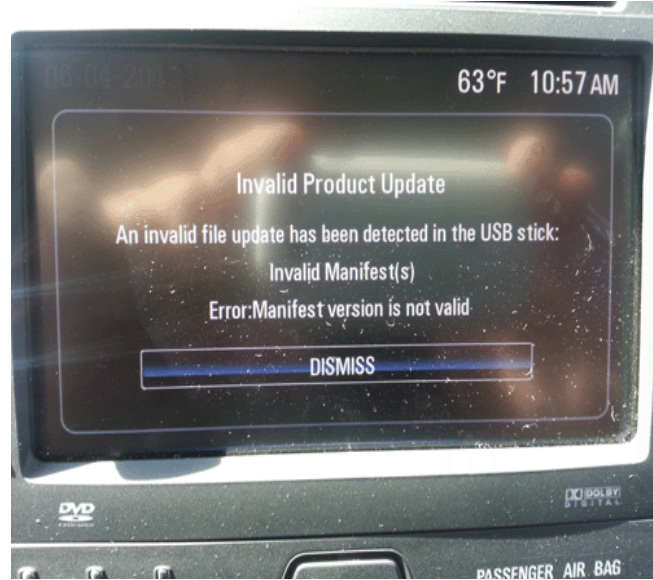
3462549

Note: If the following screen above is shown on the screen, the radio already has the latest calibration installed and no further action is required.
