Bulletin No.: PI0965

Subject: Squeaking/Creaking Type Noise Heard When Using Clutch Pedal

Models: 2012-2013 Chevrolet Sonic

Equipped with Manual Transmission (RPOs MZ4, M26)

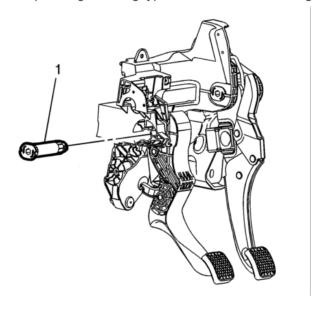
3412540

Some customers may comment on a squeaking/creaking type noise heard when using the clutch pedal.

This may be caused from lack of or no lubrication on the clutch pedal pin (1) shown in the illustration above.
