Service Bulletin

Bulletin No.: PI0967

Subject: Information on Removing Stabilizer Bar Insulator Clamp Nuts Without Damaging Electronic Power Steering Gear Boots

Models: 2013 Cadillac ATS

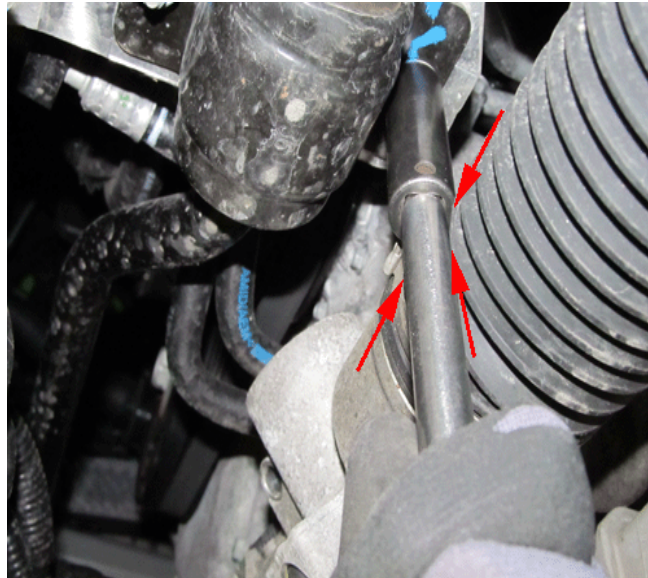
3415898

Damage to the steering gear boot could result in dirt and water contamination to the steering gear rack components requiring unnecessary replacement of the steering gear and its components.

DO NOT use a deep well socket to remove the stabilizer bar insulator clamp nuts as the socket with extension will press against the boot causing it to rub through as shown in the illustration above.
