Service Bulletin

Bulletin No.: PI0970

Subject: Difficult to Engage Clamp(s) When Installing Soft Roll-up Tonneau Cover

Models: 2014 Chevrolet Silverado Light Duty
2014 GMC Sierra Light Duty

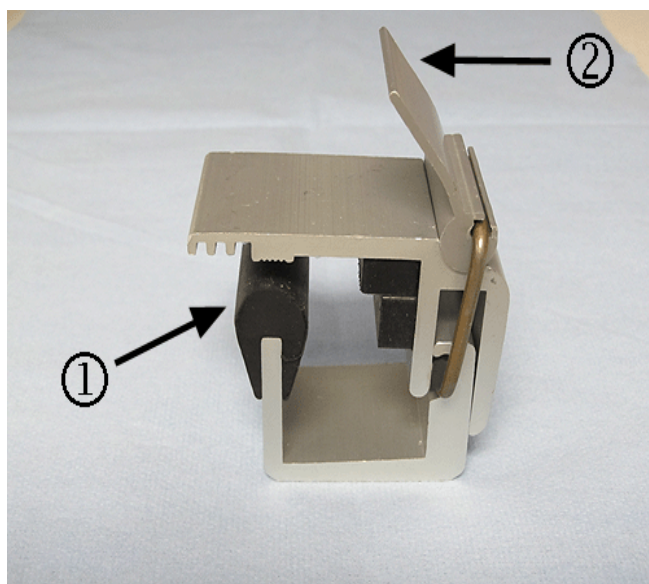
3436173

During installation of the soft tonneau cover, technicians/customers may find it difficult to engage the clamp(s).

The cause of this condition may be the clamp bulb seal (1) not compressing enough to allow the bail (2) on the clamp to rotate to the lock position.

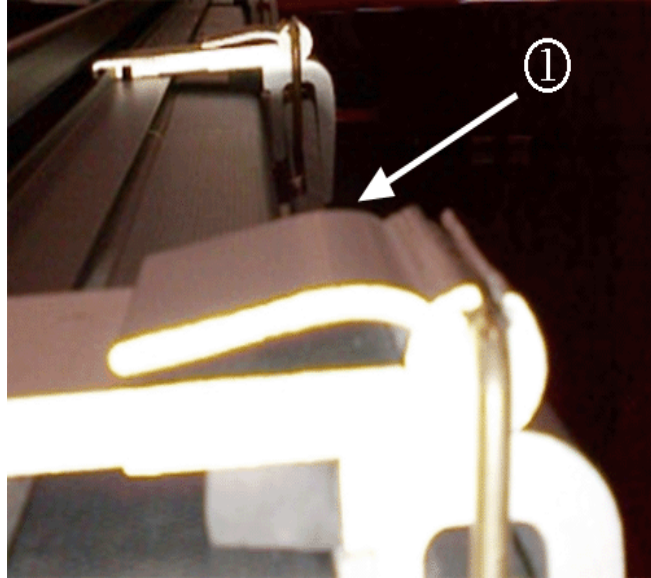
3436180

Important: Using excessive force to rotate the bail to lock position could damage the bail. If the bail of the clamp is bent (1) as shown in the graphic above, the clamp assembly will need to be replaced. The proper service part can be found in the Electronic Parts Catalog (EPC).
