Service Bulletin

Bulletin No.: PI0974

Subject: A/C Blows Warm Air, A/C Inoperative, Automatic Transmission Cooler Bracket Contacting Condenser

Models: 2012-2013 Chevrolet Impala (Police Vehicle)
Equipped with 9C1 or 9C3

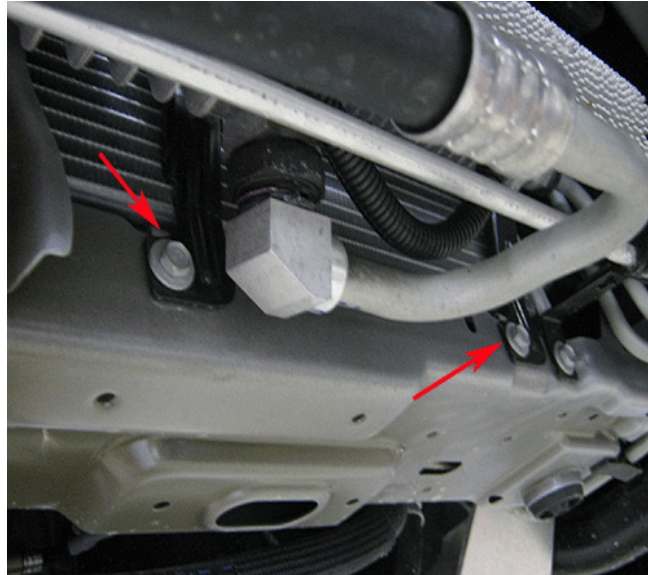
3420713

This may be caused by the transmission oil cooler bracket contacting the A/C condenser and rubbing through, resulting in a refrigerant leak.

Replace the condenser and adjust the automatic transmission oil cooler brackets (reposition at locations shown and/or install 1/8" shims) for clearance away from the A/C condenser. Refer to Air Conditioning Condenser Replacement in SI.
