# Service Bulletin

Bulletin No.: PI0977

**Subject:** Active Fuel Management (AFM) Transition Noise/Vibration Through Exhaust

**Models:** 2011-2013 Chevrolet Caprice PPV  
Equipped with 6.0L Engine (RPO L77)

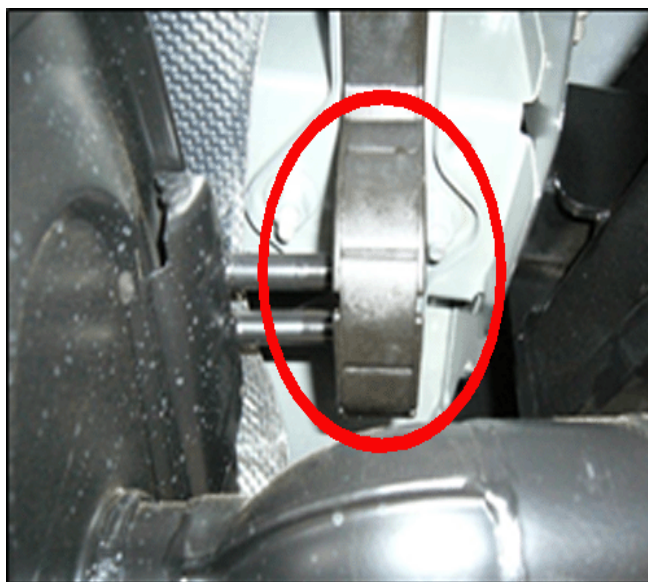
3444502

The flexible joints found in AFM Catalytic Converters must move freely in order to dampen the effects of Active Fuel Management. If the flexible joints are bound up (stressed), it is likely to cause this condition.

A tell tale sign the exhaust system is bound up is that the exhaust hangers may not pass all the way through the insulators at the rear of the vehicle. For example, the exhaust may be too far forward as shown in the illustrations above.

Disconnect the exhaust system at the catalytic converter to intermediate joints.

The rear section of the exhaust system can now be pushed rearward and also aligned so that it is central to the vehicle. The flexible catalytic converter joints will need to be pushed through their cycle of motion to ensure they can move freely.

Once done, the catalytic converter to intermediate joints must be re-tensioned to 45 N•m (33 lb ft) in an outboard to inboard sequence. This will ensure a central location for the entire exhaust system.
