Service Bulletin

Bulletin No.: PI0980

Subject: Remove Flocked Material from Front Side Door Interior Trim Panel During PDI

Models: 2013-2014 Buick Enclave
Condition/Concern

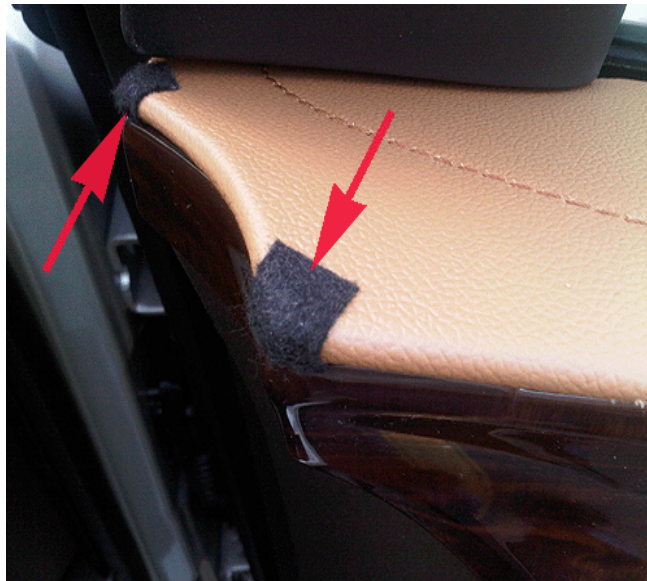
3453837

Two pieces of adhesive backed flocking material (black felt) are installed on the front side door interior trim panels as shown. This material is installed to protect the door panels during the build process.

Remove the flocking material from both front side door interior trim panels during the Pre Delivery Inspection (PDI). Clean any adhesive residue from the trim panel. Use care to not damage the finish. For information on proper interior cleaning products, refer to the latest version of Bulletin Number 06-00-89-029.
