Service Bulletin

Bulletin No.: PI0983A

Subject: Information on Accessory Bed Liner Installation for Pre-Drilled Bed Liners and for Vehicles Equipped With Upper Tie-Downs

Models: 2014 Chevrolet Silverado 1500
2014 GMC Sierra 1500

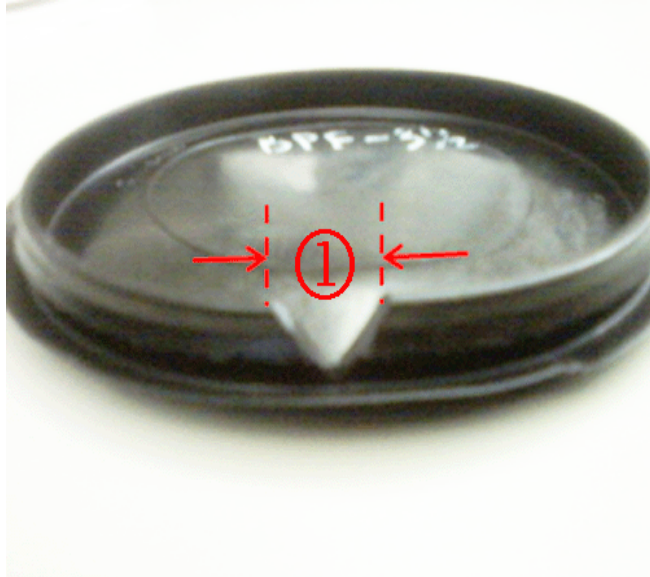
3630452

- The accessory bed liner may have pre-drilled holes to accommodate tie-downs installed in the front and rear side locations of the pickup bed. The installer may have difficulty installing the 3½" plugs provided for the holes where upper tie downs are not installed. Refer to Recommendation/Instructions #1.
- The vehicle may have upper tie-downs installed in the (front and rear) side locations of the pickup bed, however there are no access holes in the accessory bed liner that match these tie-down locations. Refer to Recommendation/Instructions #2 (Note: in this scenario, the upper tie downs will not be reconfigurable or removable).

1. Cut a relief “V” notch into the plug as shown in the graphic above. The widest distance of the “V” (1), should be approximately 12-15 mm (0.472–0.590 in).
2. Position the plug to the hole in the bed liner with the “V” notch at the bottom, and begin seating by pushing the top of plug into the hole.
