Service Bulletin

Bulletin No.: PI0988

Subject: Pop or Clunk Noise When Turning Steering Wheel at a Stop or Low Speeds

Models: 2010-2013 Chevrolet Impala

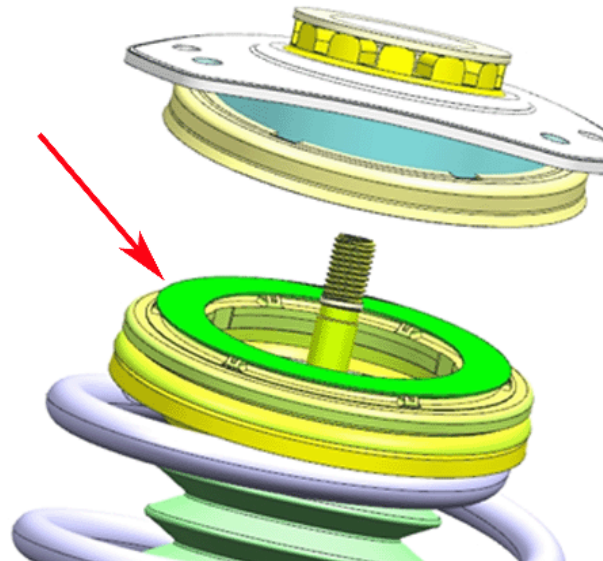
3423457

Some customers may comment on a clunk or pop type noise when turning the steering wheel at a stop or at low speeds.

Install the strut spacer as shown above. Refer to Strut, Strut Component, or Spring Replacement in SI.
