Service Bulletin

Bulletin No.: PI0998A

Subject: Accessory Tri-Fold Tonneau Cover Prevents Endgate/Tailgate from Closing

Models: 2014 Chevrolet Silverado 1500
2014 GMC Sierra 1500

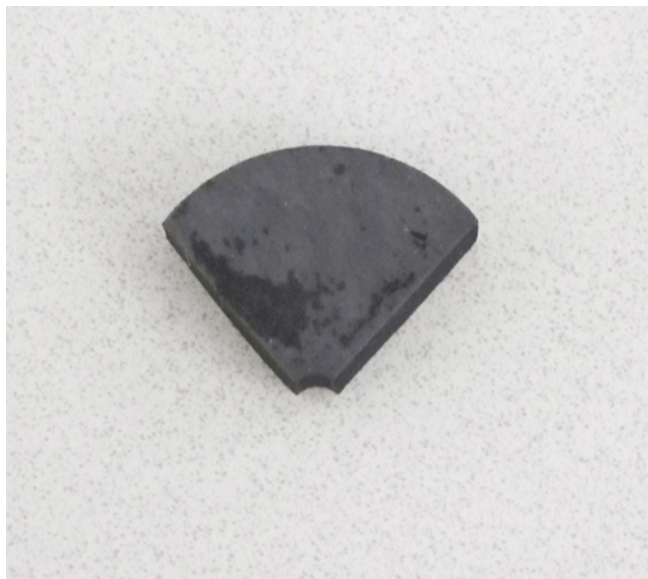
3520794

Some customers may comment that the tailgate will not close with the tri-fold tonneau cover in the closed position. This may be due to an early production condition caused by excessive twist in the rear rail of the tonneau cover, and the tailgate molding is not positioned flat on top of the tailgate.

3. Cut two pads out of the shim stock, the same shape and size as the two current rear corners pads on the tonneau rail.
