# Service Bulletin

Bulletin No.: PI0998B

**Subject:** Accessory Tri-Fold Tonneau Cover Prevents Endgate/Tailgate from Closing

**Models:** 2014 Chevrolet Silverado 1500  
2014 GMC Sierra 1500

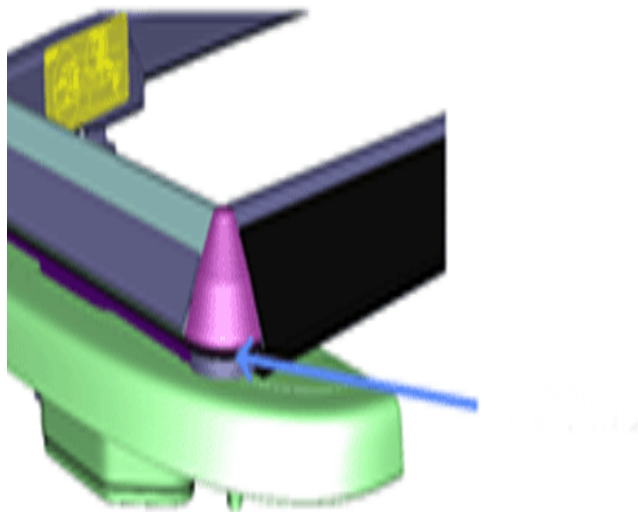
3461386

Some customers may comment that the tailgate will not close with the tri-fold tonneau cover in the closed position. This may be due to an early production condition caused by excessive twist in the rear rail of the tonneau cover, and the tailgate molding is not positioned flat on top of the tailgate.

2. Remove the adhesive liner from the pad and attach to the rear current corner pads on the right and left side as shown in the illustration above.

**Note:** If additional clearance is required, add a second layer of corner pads to each side.
