# Service Bulletin

Bulletin No.: PI1002

**Subject:** Grease or Sealant Visible on Steering Gear – Should Not Be Interpreted as Leak

**Models:** 2014 Chevrolet Silverado 1500  
2014 GMC Sierra 1500

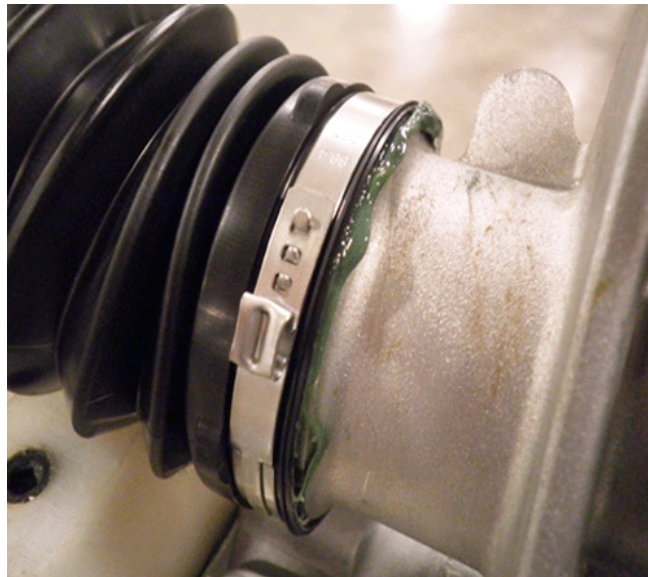
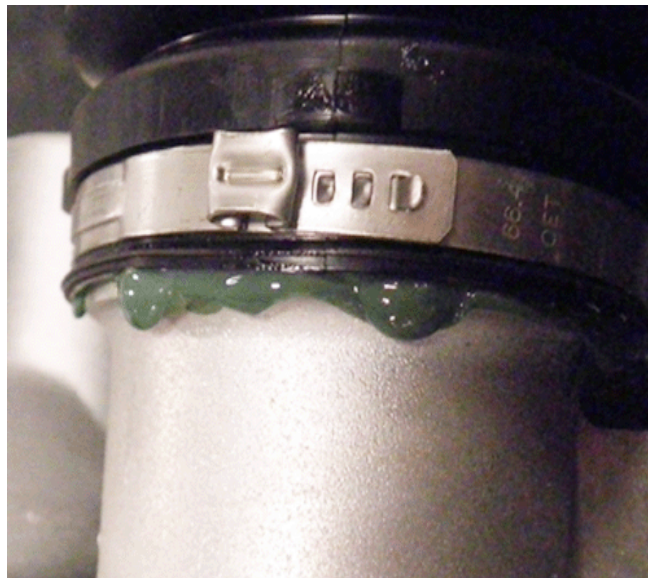
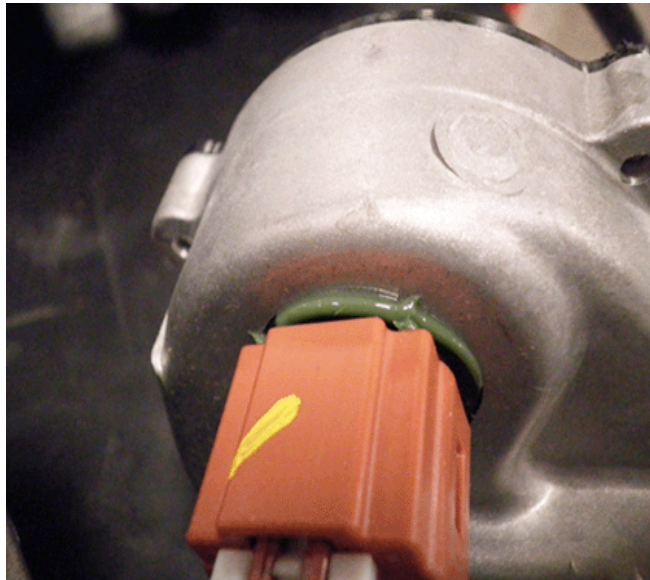
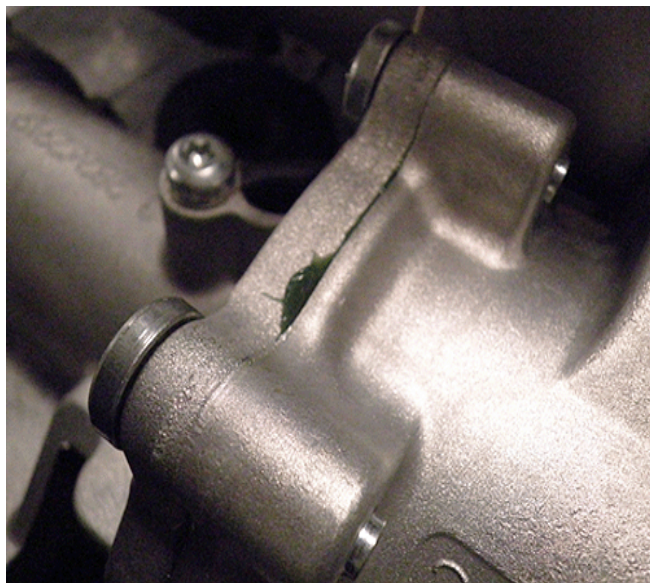
Some customers or technicians may comment on seeing grease or sealant on certain locations of the steering gear. The graphics below are examples showing some of the common areas where grease can be found.

During the manufacturing process, sufficient grease is used for lubrication and sealing of components of the steering gear. Also, sealant is added to areas of the steering gear to keep water and environmental contaminants from getting into the steering gear.

If upon inspection, the steering gear assembly clamps, boots, and fasteners are all in place, the visual evidence of grease/sealant on the exterior of the steering gear is considered normal, and **no correction** is necessary. If excess grease is noted, it should be wiped off the exterior of the gear, **however**, sealant should be left in place as a barrier to water and contamination, and no cleaning is required.

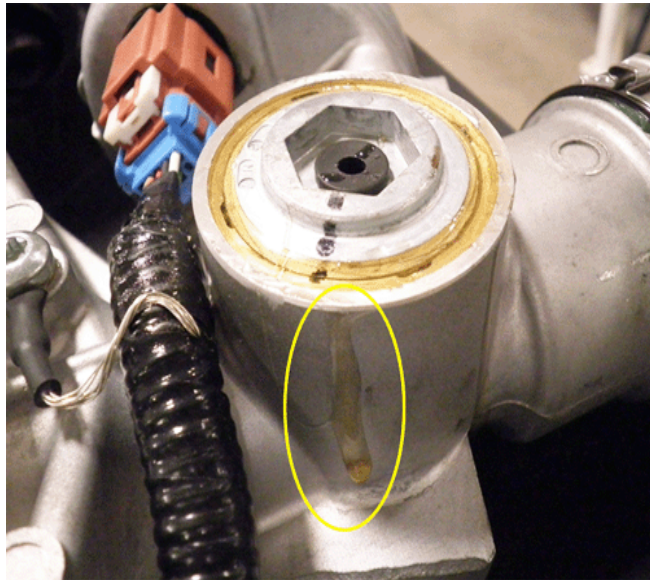
3471054

The graphic below shows a specific area where Loctite is used. The excess cured Loctite should also not be mistaken for an oil leak.
