Service Bulletin

Bulletin No.: PI1004

Subject: Malfunction Indicator Lamp (MIL) On, Service StabiliTrak, Power Steering or Vehicle Soon Message Displayed on DIC

Models: 2012-2013 Chevrolet Equinox
2012-2013 GMC Terrain
Equipped with 2.4L Engine (RPO LEA)

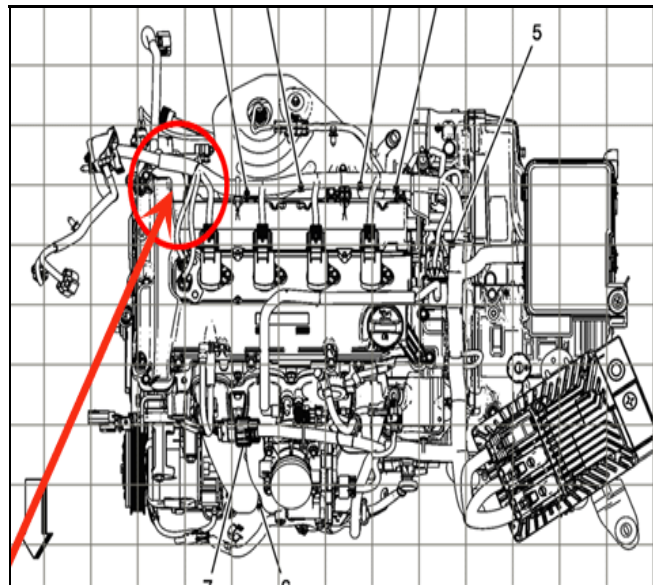
These conditions may be caused by one of the wires (in particular circuits 2500 and 2501) in the engine wiring harness being chafed, cut or damaged due to contact with the right rear corner of the engine or cam/valve cover.

Repair the affected wire. Inspect other wires in the bundle for chafes and repair if needed. Wrap the harness with additional protective tape and route the harness away from the suspect areas of engine component contact to prevent the wiring from chafing through again.
