Service Bulletin

Bulletin No.: PI1011

Subject: Radio Inoperable , No Audio, Black Screen Display

Models: 2014 Chevrolet Impala (New Body Style)
Equipped with Base Radio (RPO IO3)

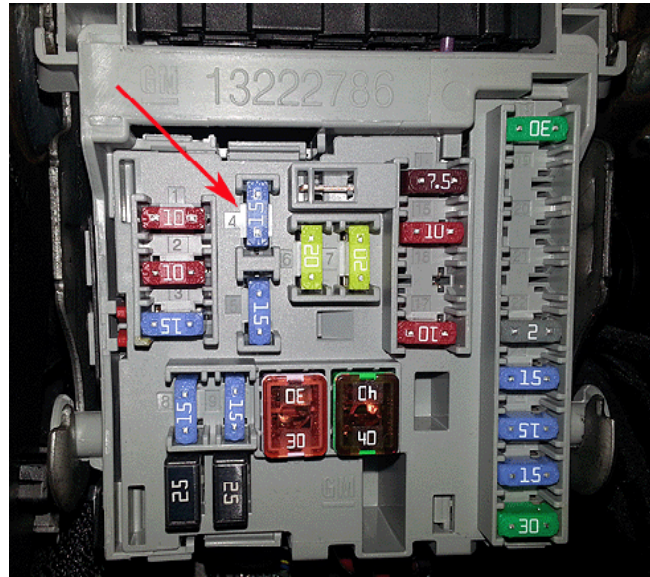
3512717

Some customers may comment that the radio is inoperable or that there is no audio and a black screen. This condition is caused by a software anomaly.

Technicians may need to pull the radio fuse if there is no response from the radio (no audio, black screen display) to exit this condition and be able to program the radio.

Important: Before updating the radio, make sure the radio fuse has been installed back into the fuse block. Update the radio using the Service Programming System (SPS) with the latest calibrations available on TIS2WEB. Refer to the SPS procedures in SI.
