Service Bulletin

Bulletin No.: P11013

Subject: A/C Blows Warm Air Intermittently

Models: 2013 Chevrolet Spark
Built Prior to November 22, 2012

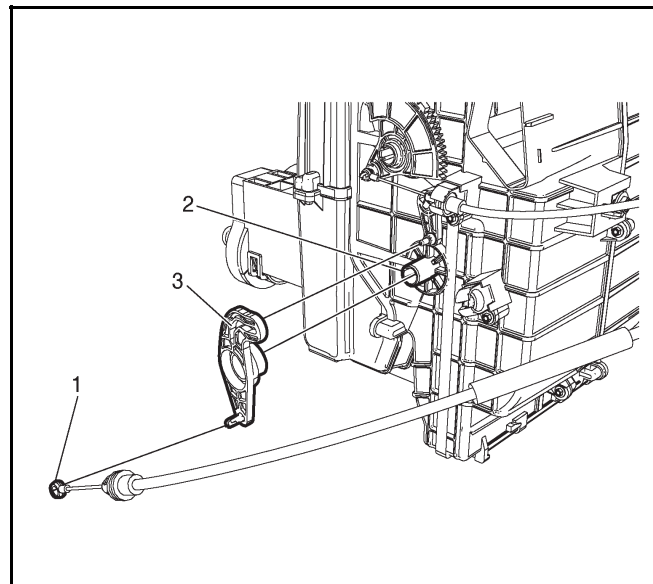
2754800

Some customers may comment on the A/C blowing warm air intermittently out of the ducts when driving at highway speeds and more noticeable on longer commutes with higher humidity.

This condition may be caused by the evaporator freezing to the point that air flow may not be able to pass through the evaporator.

1. Replace the temperature cam link (3) shown in the illustration above. Refer to Temperature Valve Link Replacement in SI.

Note: The new temperature valve link is black in color.
