Service Bulletin

Bulletin No.: PI1013A

Subject: A/C Blows Warm Air Intermittently

Models: 2013 Chevrolet Spark

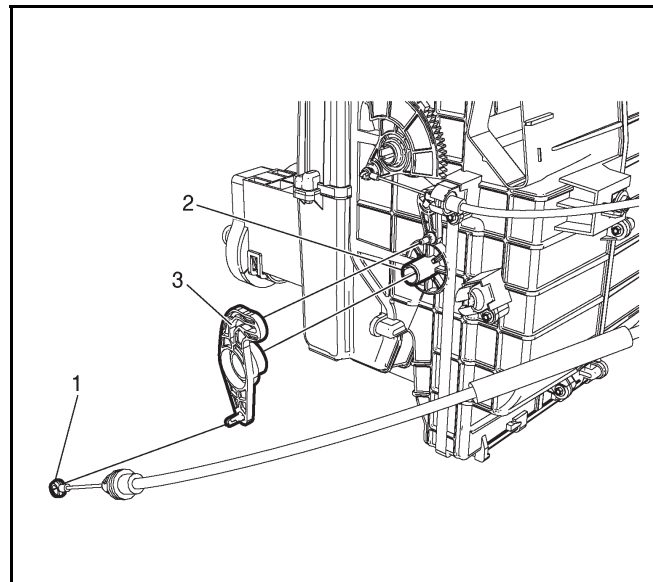
2754800

This condition may be caused by the evaporator freezing to the point that air flow may not be able to pass through the evaporator.

1. Replace the **WHITE** temperature cam link (3) shown in the illustration above with a black colored cam link. Refer to Temperature Valve Link Replacement in SI.

Note: If the temperature cam link is black in color and the vehicle is built prior to November 22, 2012 then this procedure has already been completed.
