# Service Bulletin

Bulletin No.: P11014

**Subject:** Information on Roll-up Soft Tonneau Cover Side Rail Clamp Locator Sticker Out of Position

**Models:** 2014 Chevrolet Silverado 1500  
2014 GMC Sierra 1500

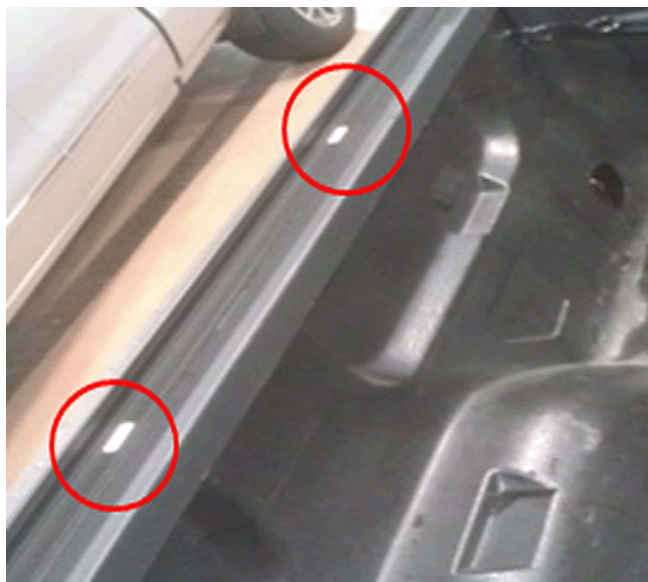
3512695

As shown circled in the graphic above, the tonneau side rails have clamp locator stickers intended to show the proper position for the tonneau clamps.

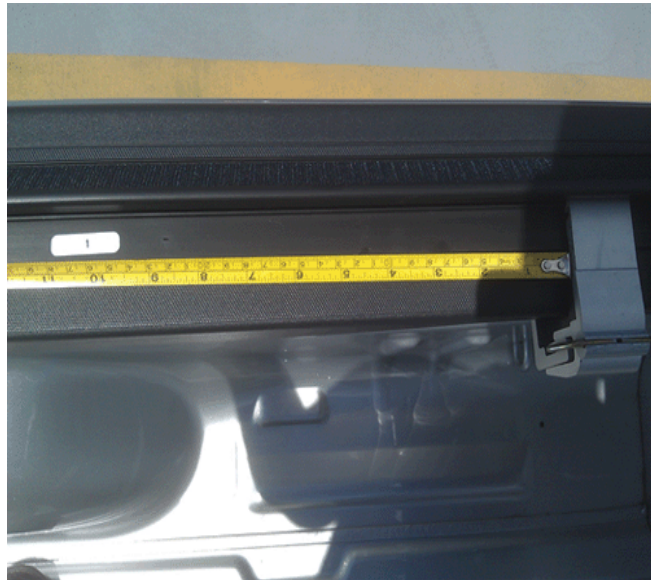
3512696

The cause of this condition may be the tonneau clamp locator stickers are positioned too far rearward within a particular segment of the early part builds. The graphic above shows an example in which the sticker is approximately 241 mm (9.5 in) too far rearward.
