Service Bulletin

Bulletin No.: P11017

Subject: Slow or Long Engine Crank, Malfunction Indicator Light On, DTC P0513 Set

Models: 2013 Buick LaCrosse, Regal
2013 Cadillac XTS
2013 Chevrolet Malibu
2014 Chevrolet Impala Limited
Equipped with 2.0L (RPO LTG), 2.5L (RPO LCV), 2.5L (RPO LKW) or 3.6L (RPO LFX)
Engine

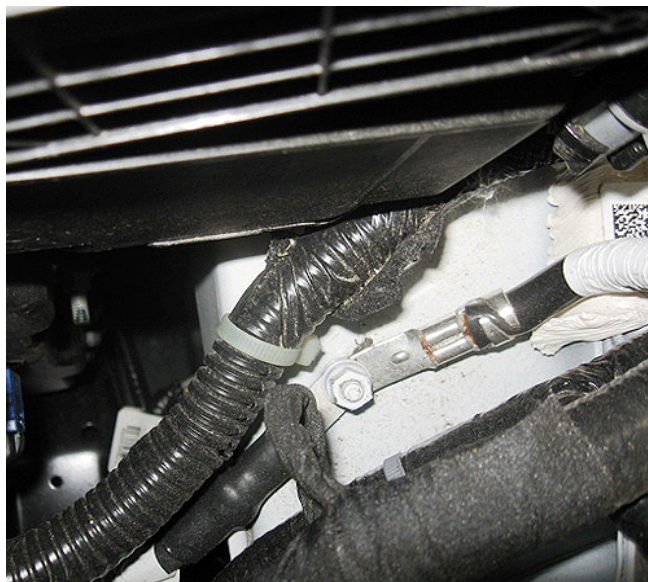
2014 Chevrolet Impala Limited shown, others similar

Vehicle	G103 Location
LaCrosse	In the engine compartment, below the left radiator support core, fourth from the top
Regal	In the engine compartment, on the left side, forward of the battery
XTS	In the engine compartment, left front, on frame rail
Impala	In the engine compartment, front left of center, on frame rail forward of battery
Malibu	In the engine compartment, forward of the battery

Technicians should inspect for a loose connection at G103. Clean and ensure the terminals are indexed properly so that it is fully seated on the stud prior to tightening the G103 terminal to 11.2 N•m (99 lb in).
