Service Bulletin

Bulletin No.: PI1017A

Subject: Slow or Long Engine Crank, Malfunction Indicator Light On, DTC P0513 Set

Models: 2013 Buick LaCrosse, Regal
2013 Cadillac XTS
2013 Chevrolet Malibu
2014 Chevrolet Impala
Equipped with 2.0L (RPO LTG), 2.5L (RPO LCV), 2.5L (RPO LKW) or 3.6L (RPO LFX) Engine

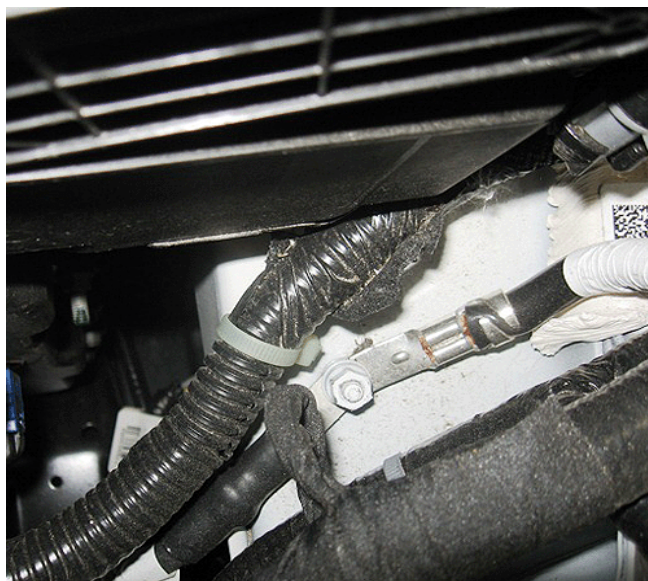
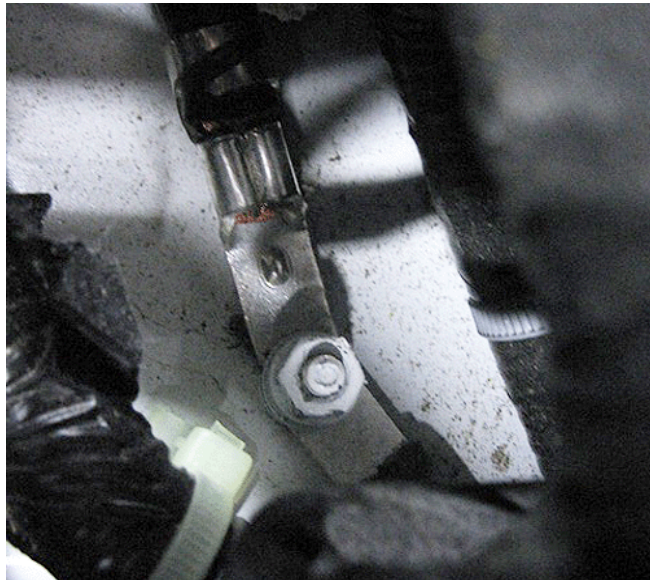
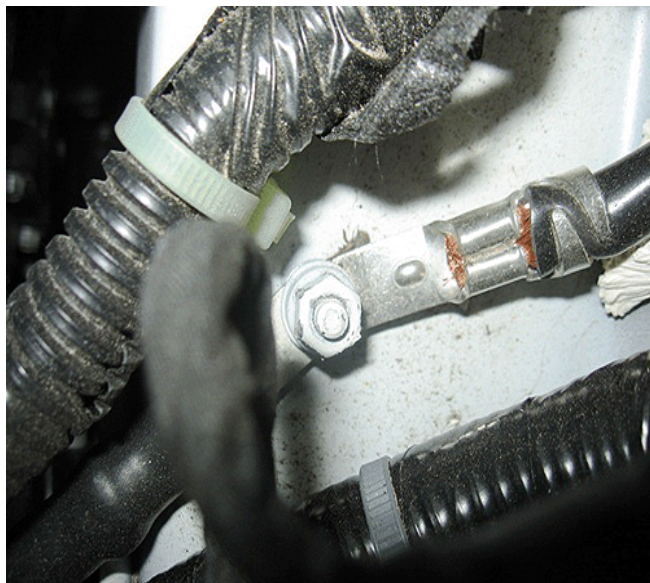
2014 Chevrolet Impala shown, others similar

Vehicle	G103 Location
LaCrosse	In the engine compartment, below the left radiator support core, fourth from the top
Regal	In the engine compartment, on the left side, forward of the battery
XTS	In the engine compartment, left front, on frame rail
Impala	In the engine compartment, front left of center, on frame rail forward of battery
Malibu	In the engine compartment, forward of the battery

Technicians should inspect for a loose connection at G103. Clean and ensure the terminals are indexed properly so that it is fully seated on the stud prior to tightening the G103 terminal to 11.2 N•m (99 lb in).
