# Service Bulletin

Bulletin No.: P11020

**Subject:** Rattle/Squeak Noise and/or Rear of Center Console Loose

**Models:** 2013 Cadillac ATS  
Vehicles Built Prior to May 10, 2013

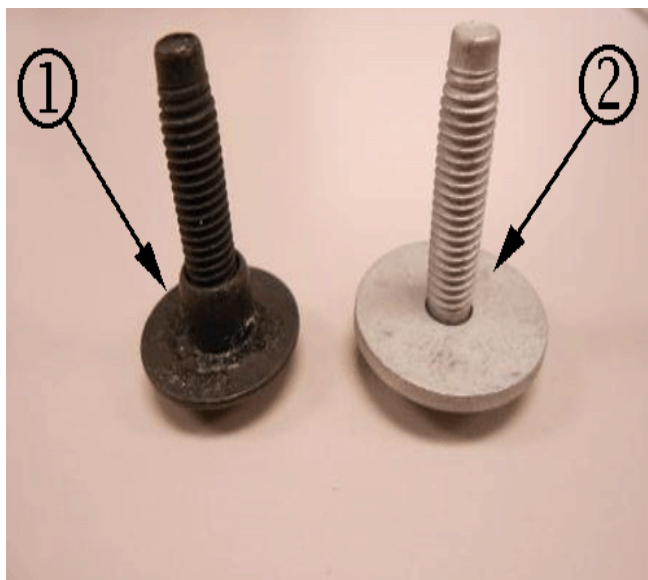
3449043

Some customers may comment on a squeak/rattle type noise heard and/or the rear center console may be loose. This may be due to a design change with the rear of the center console that may cause the two rear attaching bolts to bottom out before being fully secured.

**Note:** (1) is the bolt used during production, (2) is the revised bolt being used
