MIL "ON" DTC P0418 and/or P2445

Service Category Engine/Hybrid System

Section Engine Control

YEAR(S)	MODEL(S)	ADDITIONAL INFORMATION
2012 – 2013	Sequoia	
2012 – 2013	Tundra

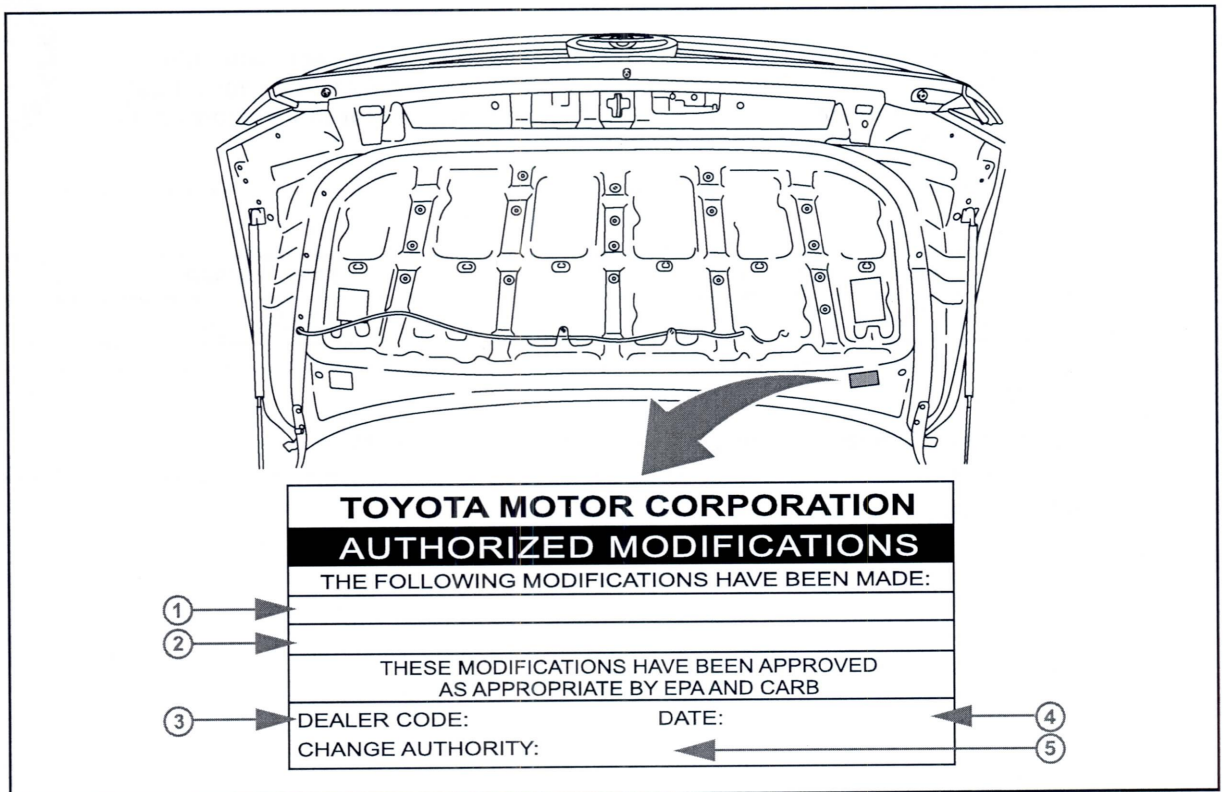
Figure 1. Location of Authorized Modifications Label on 2012 – 2013 Sequoia and Tundra

2. Check for the Authorized Modifications Label affixed to the vehicle in the location shown in Figure 1. Confirm if the ECM (PCM) calibration has been updated. If the calibration ID listed is NOT the latest ECM (PCM) calibration — go to step 3.

B. Affix the Authorized Modifications Label to the vehicle at the location shown in Figure 1. The Authorized Modifications Label is available through the MDC, P/N 00451-00001-LBL.
