TECHNICAL BULLETIN  
Q344NAS1  
10 DEC 2013

**SECTION: 414-01**

Service Action: Battery Cable Ground Connection

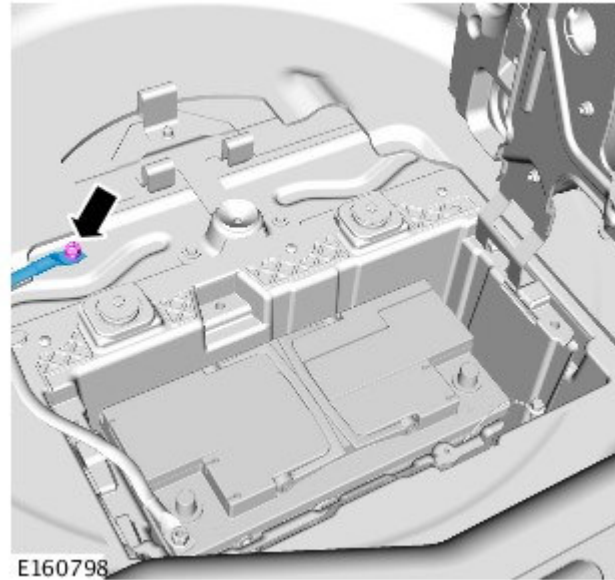
**Situation:** A potential issue has been identified with the battery cable ground connection torque check on a limited number of vehicles within the listed model year and VIN range.

Inspect the battery ground cable connection:

- Make sure the nut is not cross threaded on the ground stud.
  - If the nut is not cross threaded, tighten the nut to 9Nm.
  - If the nut is cross threaded, repair as necessary, making sure the nut is tightened to 9Nm; to be performed as a separate claim.
