## HORTON ENGINEERING CHANGE NOTICE

ECN 1388

### REPLACING THE SIDE ENTRY DOOR GAS SPRING/ SHOCK

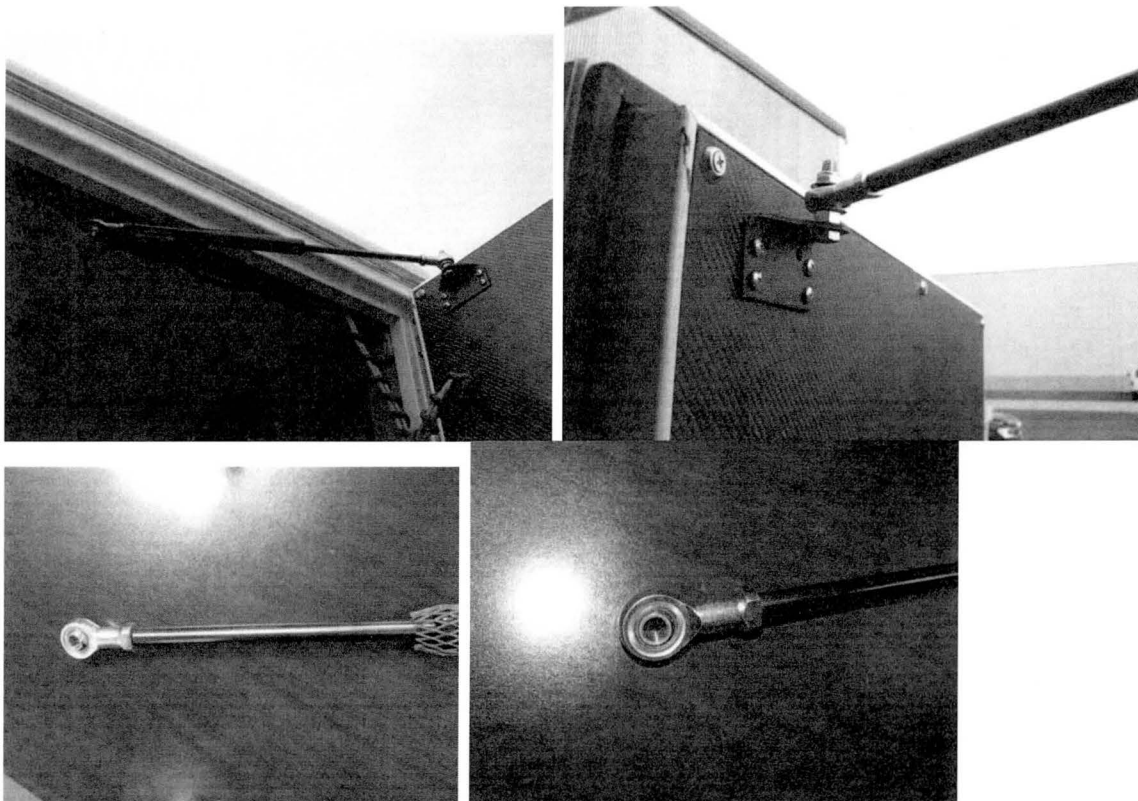
This ECN is for changing the standard Suspa side entry door gas spring PN 10009821 to Suspa (C16-31016) PN 10012912. We have been experiencing some failures with the current gas spring on side entry doors. The current fixed clevis (NYC Style) is breaking and some of the shafts are bending. To correct the problem, we designed a new gas spring with thicker shaft 0.390" and larger cast clevis. In addition, the new clevis is a swivel style and will relieve any additional angle stress on gas spring. The new design will provide better support for our side entry doors and will compensate for angle variation in the install process. See attached pictures for the new gas spring. (Field retrofit will require bracket relocation on door jamb and new lower close out board, use same brackets and hardware)
