Service Bulletin

Bulletin No.: PIC5799

Subject: Wind Rush or Excessive Road Noise While Driving

Models: 2013 Cadillac ATS

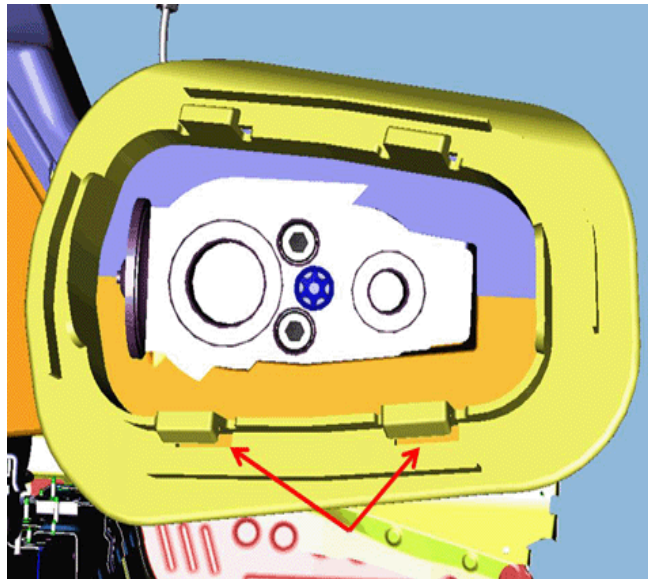
3241824

The vehicle may have an excessive wind rush noise or road noise while driving. This could be caused by a foam seal that has been mis-positioned during assembly or certain service repairs in the area of the AC refrigerant TXV (Thermal Expansion Valve) pass-through.

1. The foam seal should extend down enough to cover the lower rectangular holes by the tabs on the trim plate by the TXV. If the holes are exposed, road noise can enter the passenger compartment.
2. It is possible the foam seal for the HVAC case may be mis-positioned or rolled during assembly.

1. Cover the lower holes in the trim plate from behind by reaching inside the bezel. Apply duct tape to cover the back side of those holes.
2. If covering the holes does not correct the condition, remove the HVAC case and inspect the foam seal. Reposition or replace as needed.
