Service Bulletin

Bulletin No.: PIC5824

Subject: Normal Characteristic - Radio Center Select Button Is Inoperative On ICS And/Or Touch Screen Is Inop

Models: 2013 Buick Encore
With Navigation Radio (RPO UHQ)

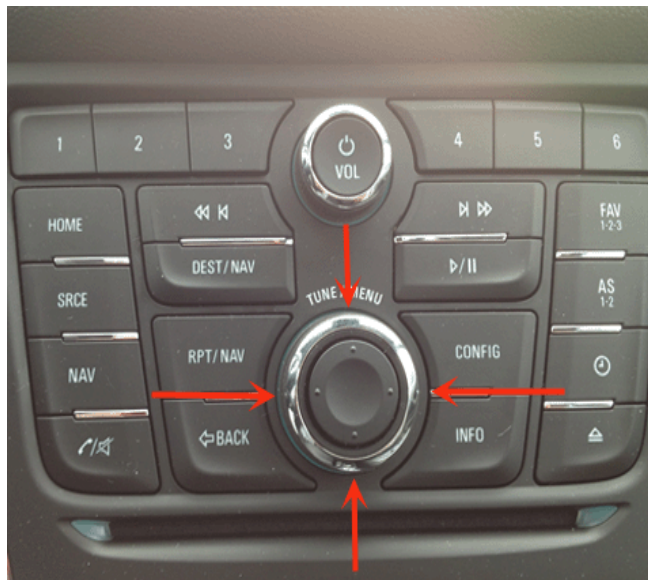
3338368

1. The center Joystick ONLY operates when in the Map Mode. The large chrome dial in the center of the ICS must be used to make a selection then the chrome outer edge needs to be pressed in to make the Selection. See photo below:

Important: Do NOT replace any parts for the concern
