Bulletin No.: PIC5827

Service Bulletin

Subject: Oval Cutout Or Void In Carpet Visible On Passenger Side Of Center Console

Models: 2013 Cadillac ATS built prior to 12/21/12

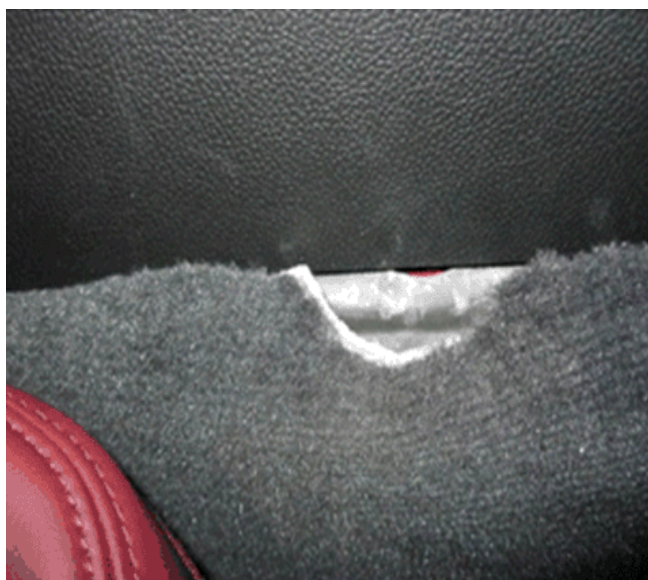
3319635

Some customers may comment that there is an oval cutout or void in the carpet on the passenger side of the center console.

The carpet is cut correctly and does not need to be replaced. Instead, the carpet fit must be finessed. Remove the console to allow the carpet to rise to proper position. Then reinstall console.

If the carpet does not come up enough for the notch to be covered, the seat may need to be removed to allow the carpet some slack. (Be sure to refer to PIC5807 before removing the seat bolts.)

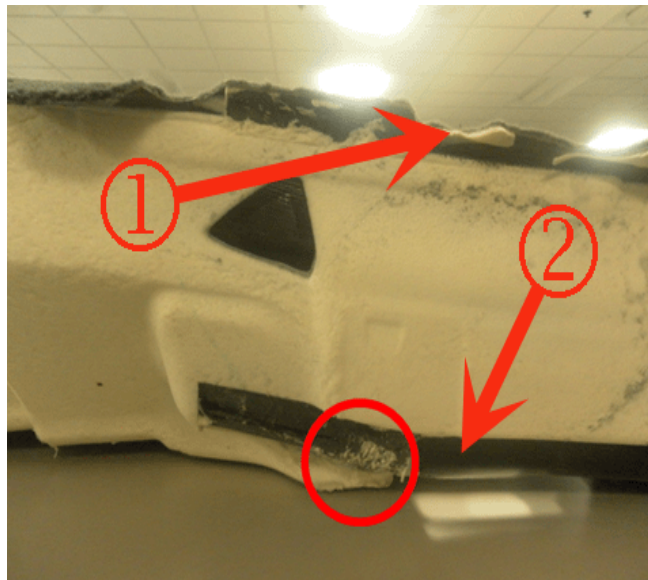
3319637

1. Area of defect.
2. Same hole both pictures. Temporary rework removing foam to improve ease of seat track cover install. With no foam, carpet is allowed to be pushed down pulling notch with it.

If the carpet does not stay up under the console, foam may need to be added under the carpet on the floor near the console. Refer to picture below.

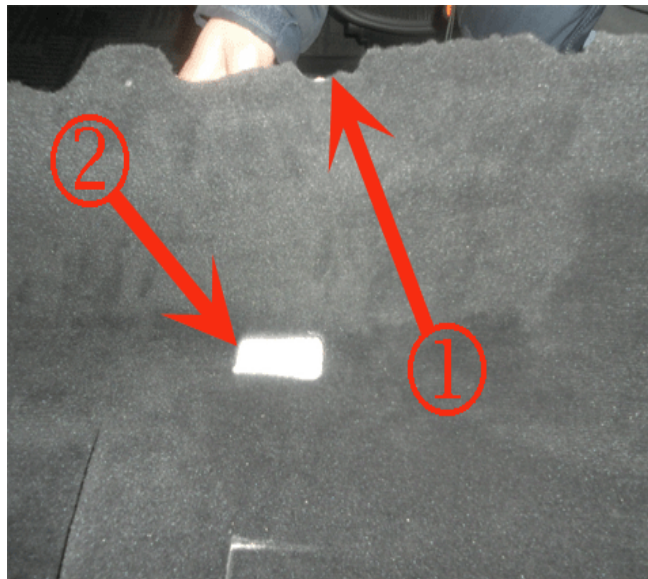
3319638

1. Area of defect.
2. Same hole both pictures.
