Service Bulletin

Bulletin No.: P11032

Subject: Click Noise Heard from Front Compartment Area, Possible DTC P059F Set

Models: 2014 Chevrolet Spark EV
Condition/Concern

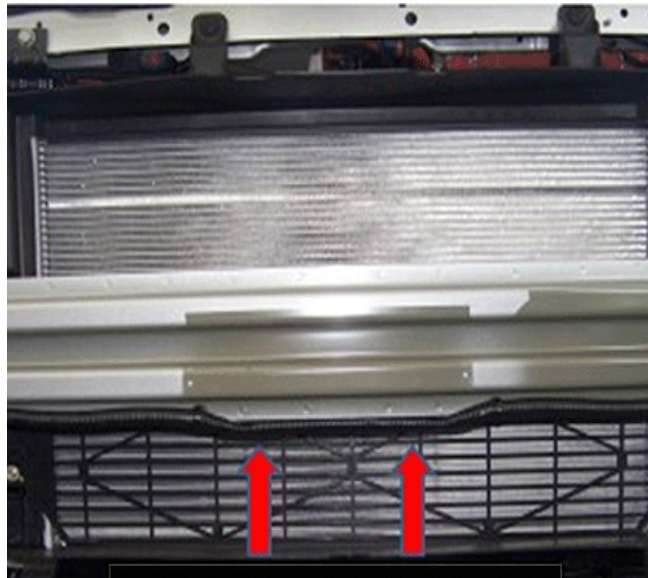
3596935

This condition may be caused by the harness dropping down during installation of the front fascia and causing the air shutter housing to be pushed down and contact the louvers when opening or closing.

Reposition the wiring harness by taping up the harness as shown below. Once the front fascia assembly is installed, the harness will be supported by the shutter housing.
