Service Bulletin

Bulletin No.: P11040

Subject: Mobile Telephone Microphone Poor Performance

Models: 2013 Buick Enclave
2013 Chevrolet Traverse
2013 GMC Acadia

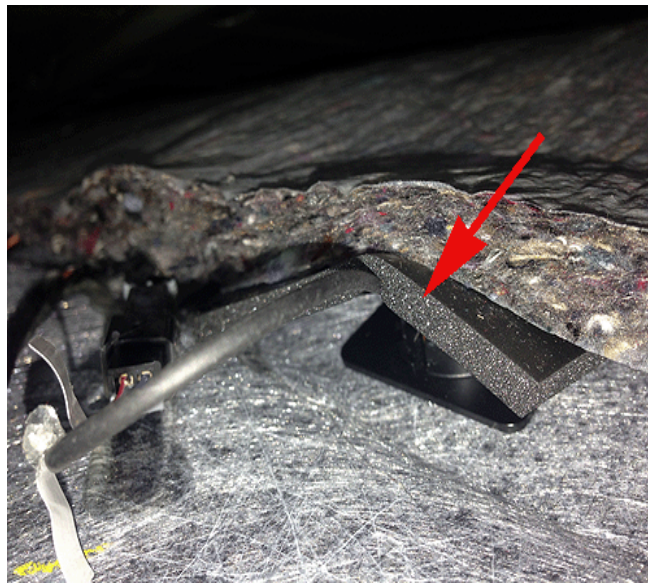
3541395

The foam patch on the back of the headliner at the microphone mounting area may have come loose. This foam is a sound barrier for the back side of the microphone. If the patch is detached, it allows unwanted noise to interfere with the microphone operation when making a phone call.

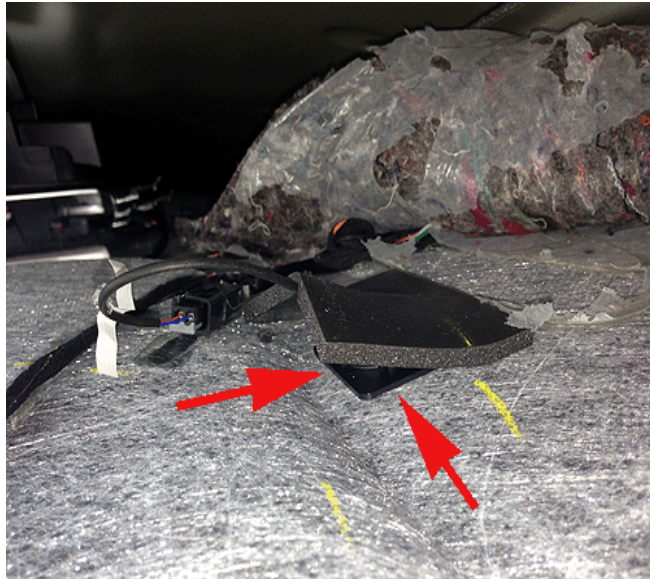
3541396

2. Locate the mobile telephone microphone. Inspect the foam patch on the back of the microphone and determine if the patch is firmly attached to the headliner trim panel as shown.

- If the foam patch is not firmly attached, Using a hot glue gun, apply GM P/N 12377914 (in Canada, use 88864881) Hot Melt Adhesive to firmly attach the foam patch to the headliner trim panel.

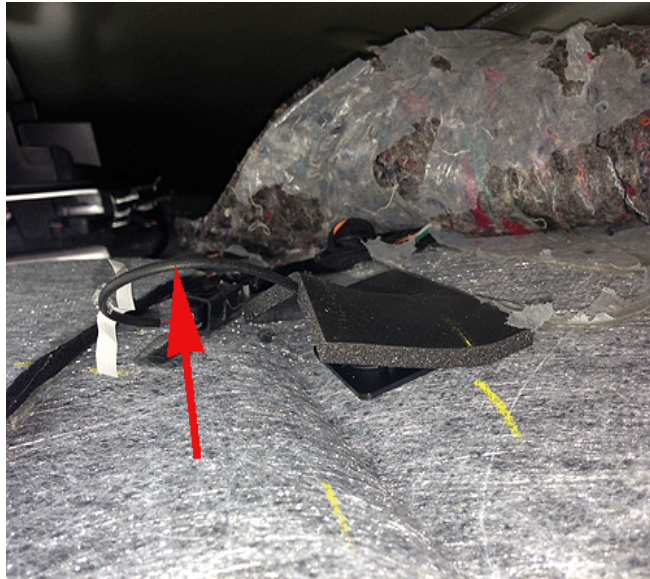
3541387

3. Inspect the mobile telephone microphone wiring harness and verify the harness is firmly attached to the headliner trim panel as shown.

- If the wiring harness is not firmly attached, Using a hot glue gun, apply GM P/N 12377914 (in Canada, use 88864881) Hot Melt Adhesive to firmly attach the harness to the headliner trim panel.
4. Reinstall the left body lock pillar upper trim panel. Refer to Body Lock Pillar Upper Trim Panel Replacement in SI.
 5. Reinstall the roof console assembly. Refer to Roof Console Replacement in SI.
 6. Reinstall the sunshade assemblies. Refer to Sunshade Replacement in SI.
 7. Reinstall the sunshade anchors. Refer to Sunshade Anchor Replacement in SI.
 8. Reinstall the windshield garnish moldings. Refer to Windshield Garnish Molding Replacement - Left Side and Windshield Garnish Molding Replacement - Right Side in SI.
 9. Enable the roof rail SIR system. Refer to SIR Disabling and Enabling in SI.
