Service Bulletin

Bulletin No.: PI1061

Subject: Waterleak from Headliner at A/C Outlet Vents or Dome Light Above 2nd or 3rd Row Seating Positions

Models: 2012-2014 Buick Enclave
2012-2014 Chevrolet Traverse
2012-2014 GMC Acadia

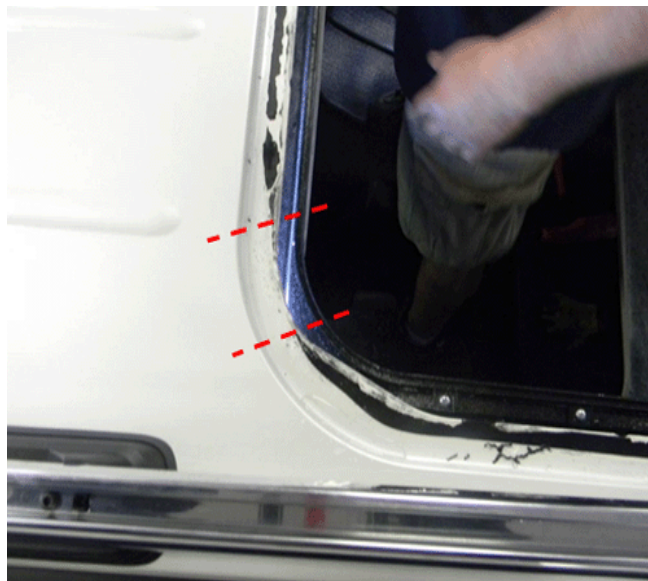
The cause of this condition may be voids in the urethane of the sunroof rear stationary window. These voids may allow water to leak between the urethane and roof flange, then onto the headliner.

To properly verify that the leak is from the sunroof rear stationary glass, use a soapy solution and compressed air. The more common areas where leaks may be found is at the center rear edge of the glass, or in the front or rear corners of the glass. Several examples are shown in the graphics below.

If a leak is confirmed, remove and reseal the glass. Refer to Roof Stationary Window Replacement in SI.

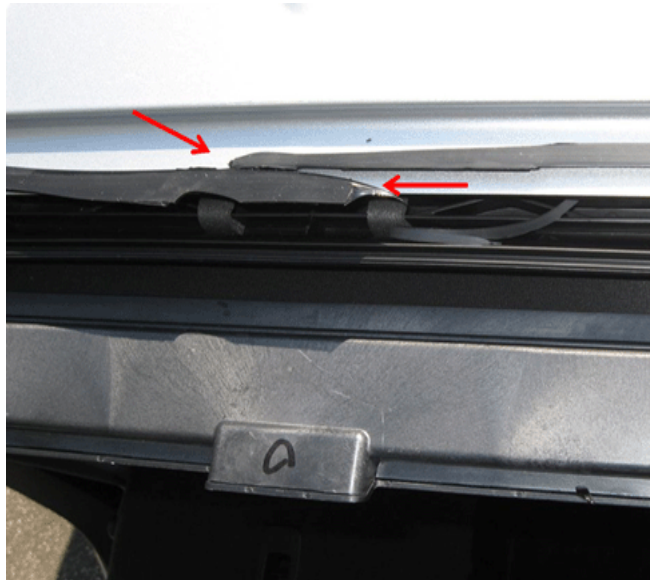
3619170

The graphic below shows an example of a leak caused by the urethane not being properly aligned.
