# Service Bulletin

Bulletin No.: PI1067

**Subject:** Malfunction Indicator Lamp (MIL) Light On, Reduced Power Mode, DTC Set, Poor Performance/Shifts

**Models:** 2013-2014 Chevrolet Equinox  
2013-2014 GMC Terrain  
Equipped with 3.6L Engine (RPO LFX)

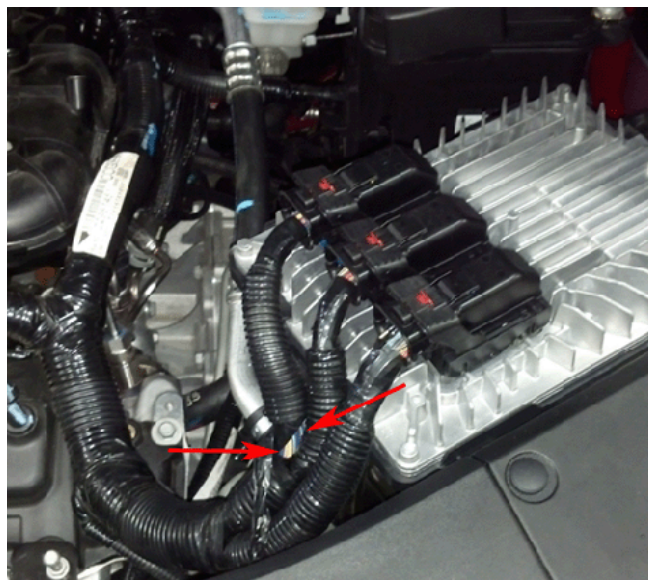
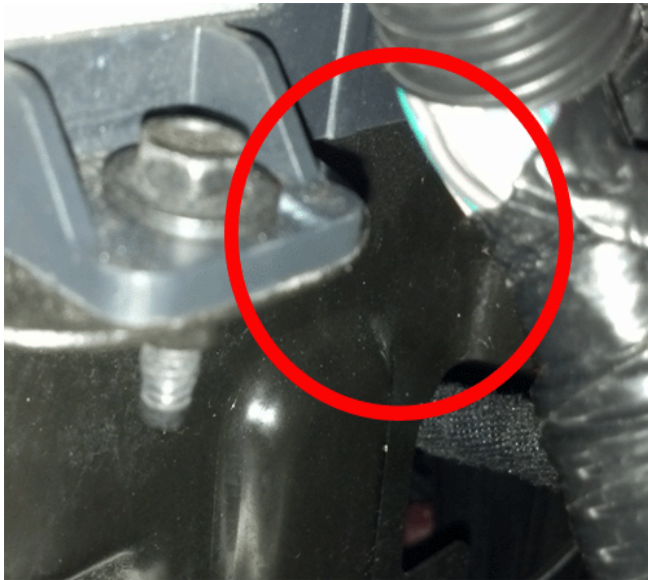
3617976

This condition may be caused by the ECM wiring harness rubbing on the ECM bracket. The harness may have chafing or damage to the wires. Contact with the edge of the bracket may result in a rub-through of the wires within that harness.

Technicians should inspect the ECM harness (off of Engine Control Module X1 connector) for any damaged wires at the location shown below and repair any damaged wires found. Refer to Wiring Repairs in SI. After the repair is completed, wrap Woven Polyester Electrical Tape (PET) (preferred) or equivalent anti-abrasion tape around the wires on the harness.
