Service Bulletin

Bulletin No.: PI1071A

Subject: Transmission Fluid Leak at Auxiliary Pump Seal

Models: 2014 Chevrolet Malibu
Equipped with 6T40 Automatic Transmission (RPO MNH)

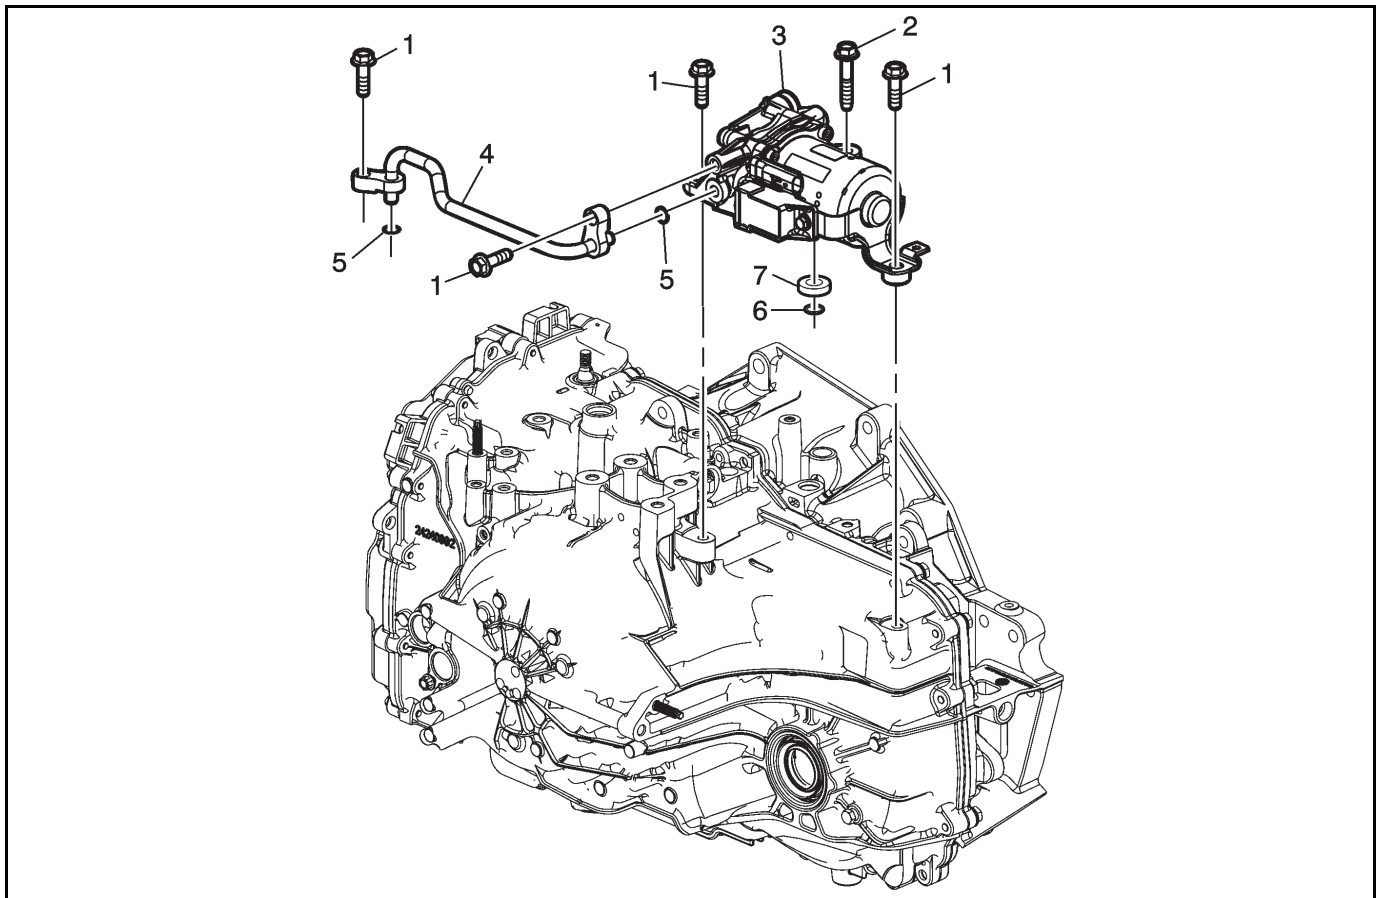
2552766

Investigation of the leak may show that the fluid is leaking on top of the transmission at the auxiliary fluid pump seal (6).

If leak diagnosis determines that the leak source is the auxiliary fluid pump seal, it should be replaced.

Important: To prevent damage to the replacement seal, be sure to lubricate the seal with transmission fluid before installing the auxiliary pump.
