Service Bulletin

Bulletin No.: P11075

Subject: Locking Fuel Tank Filler Door Not Locking/Unlocking

Models: 2010-2014 Cadillac SRX with RPO N08

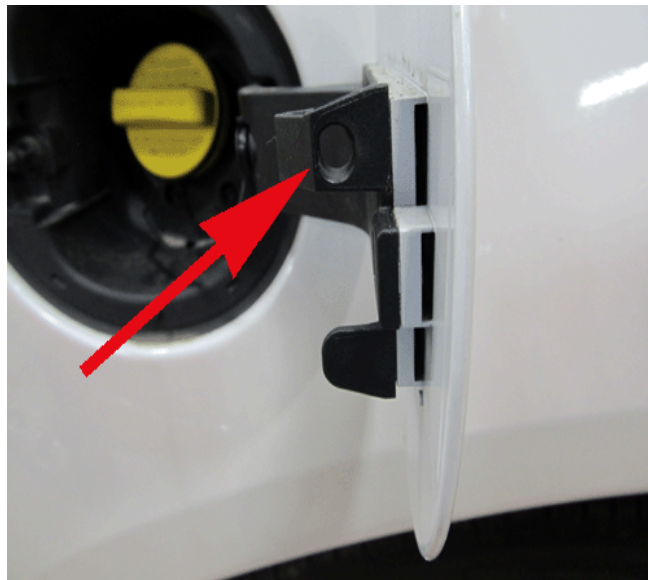
3629547

2. Locate the oval shaped locking pin engagement hole on the inner fuel tank filler door.
