Service Bulletin

Bulletin No.: PI1091

Subject: Warm Air Exhausting from Driver and/or Passenger Front Seat Back into 2nd Row Seating Area Causing Occupant Discomfort

Models: 2014 Chevrolet Silverado 1500
2014 GMC Sierra 1500
Equipped with Heated and Cooled Seats - Driver and Passenger Front (RPO KB6)

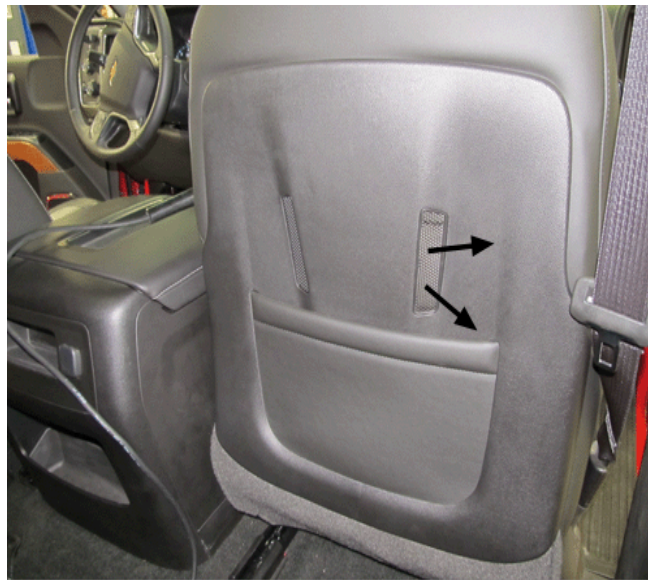
3636141

Some customers may comment on warm air exhausting from the driver/passenger front seat back into the 2nd row seating area, causing occupant discomfort.

The cause of this condition may be that during cooled seat operation, a direct flow of warm air exhausts from the upper seat back ventilation heating/cooling blower.
