# Service Bulletin

Bulletin No.: PI1097

**Subject:** Intermittent Service Power Steering Message on Vehicle Start Up

**Models:** 2013-2014 Cadillac ATS  
**Condition/Concern**

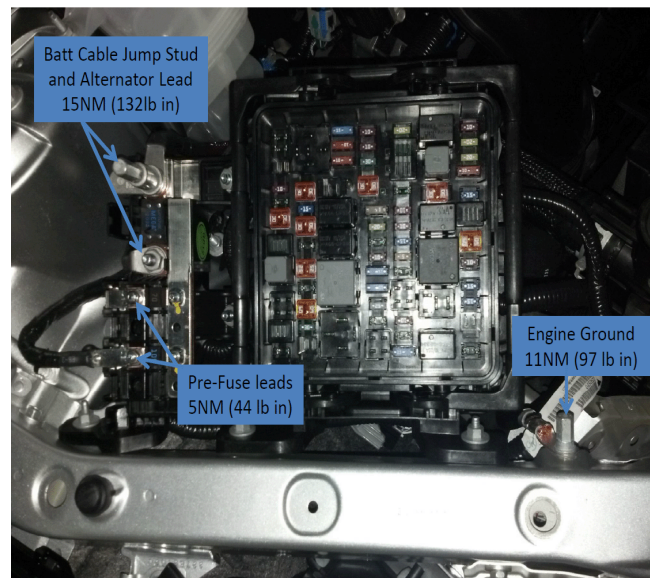
3648055

If no DTCs are present, the issue may be caused by a momentary loss of power or ground in the power steering gear circuits.

1. Inspect the underhood fuse block power and ground connections for proper torque as identified in the above photo.

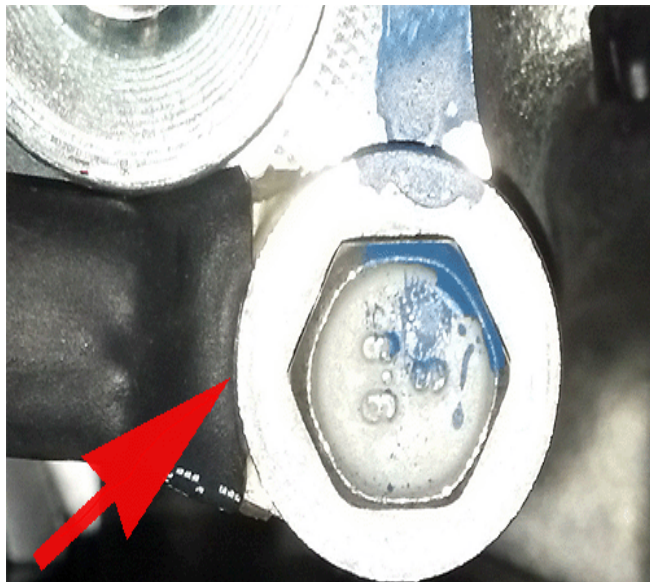
3575838

Look for either excess shrink wrap or glue under the eyelet. Inspect for adhesive that has seeped out onto the eyelet during the heating of the shrink tube, or the shrink tube itself extending into the eyelet area.

**Important:** It is not an adequate check to simply try to wiggle the ground wire to check for looseness. The ground must be removed and checked for these items, cleaned and reinstalled.

3. Carefully trim the heat shrink tube if needed, clean adhesive from the eyelet (sand off), reinstall and torque.
