Service Bulletin

Bulletin No.: PI1099

Subject: Rear Door Weatherstrip Protrudes from Door Opening at Rear Beltline

Models: 2014 Chevrolet Silverado 1500 (Crew Cab only)
2014 GMC Sierra 1500 (Crew Cab only)

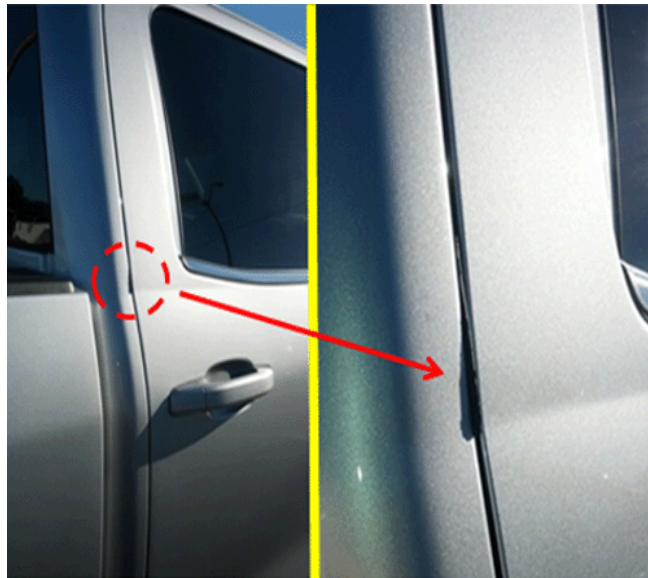
3646024

Some customers may comment on the driver or passenger side rear door weatherstrip protruding from the door opening at the rear beltline.

The cause of this condition may be the combination of the variance in excess weatherstrip seal mold in the forming process and/or individual rear door positioning.

Important: Do not replace the rear door weatherstrip for this condition.

Trim the "flag" portion of the weatherstrip seal to match the contour of the rear door, following the repair steps below:
